# **SIKA AT WORK** HINCKLEY POINT B POWER STATION

REFURBISHMENT: Sikacem®-133GP Gunite

#### **SPRAY APPLIED CONCRETE SOLUTION AT POWER STATION**

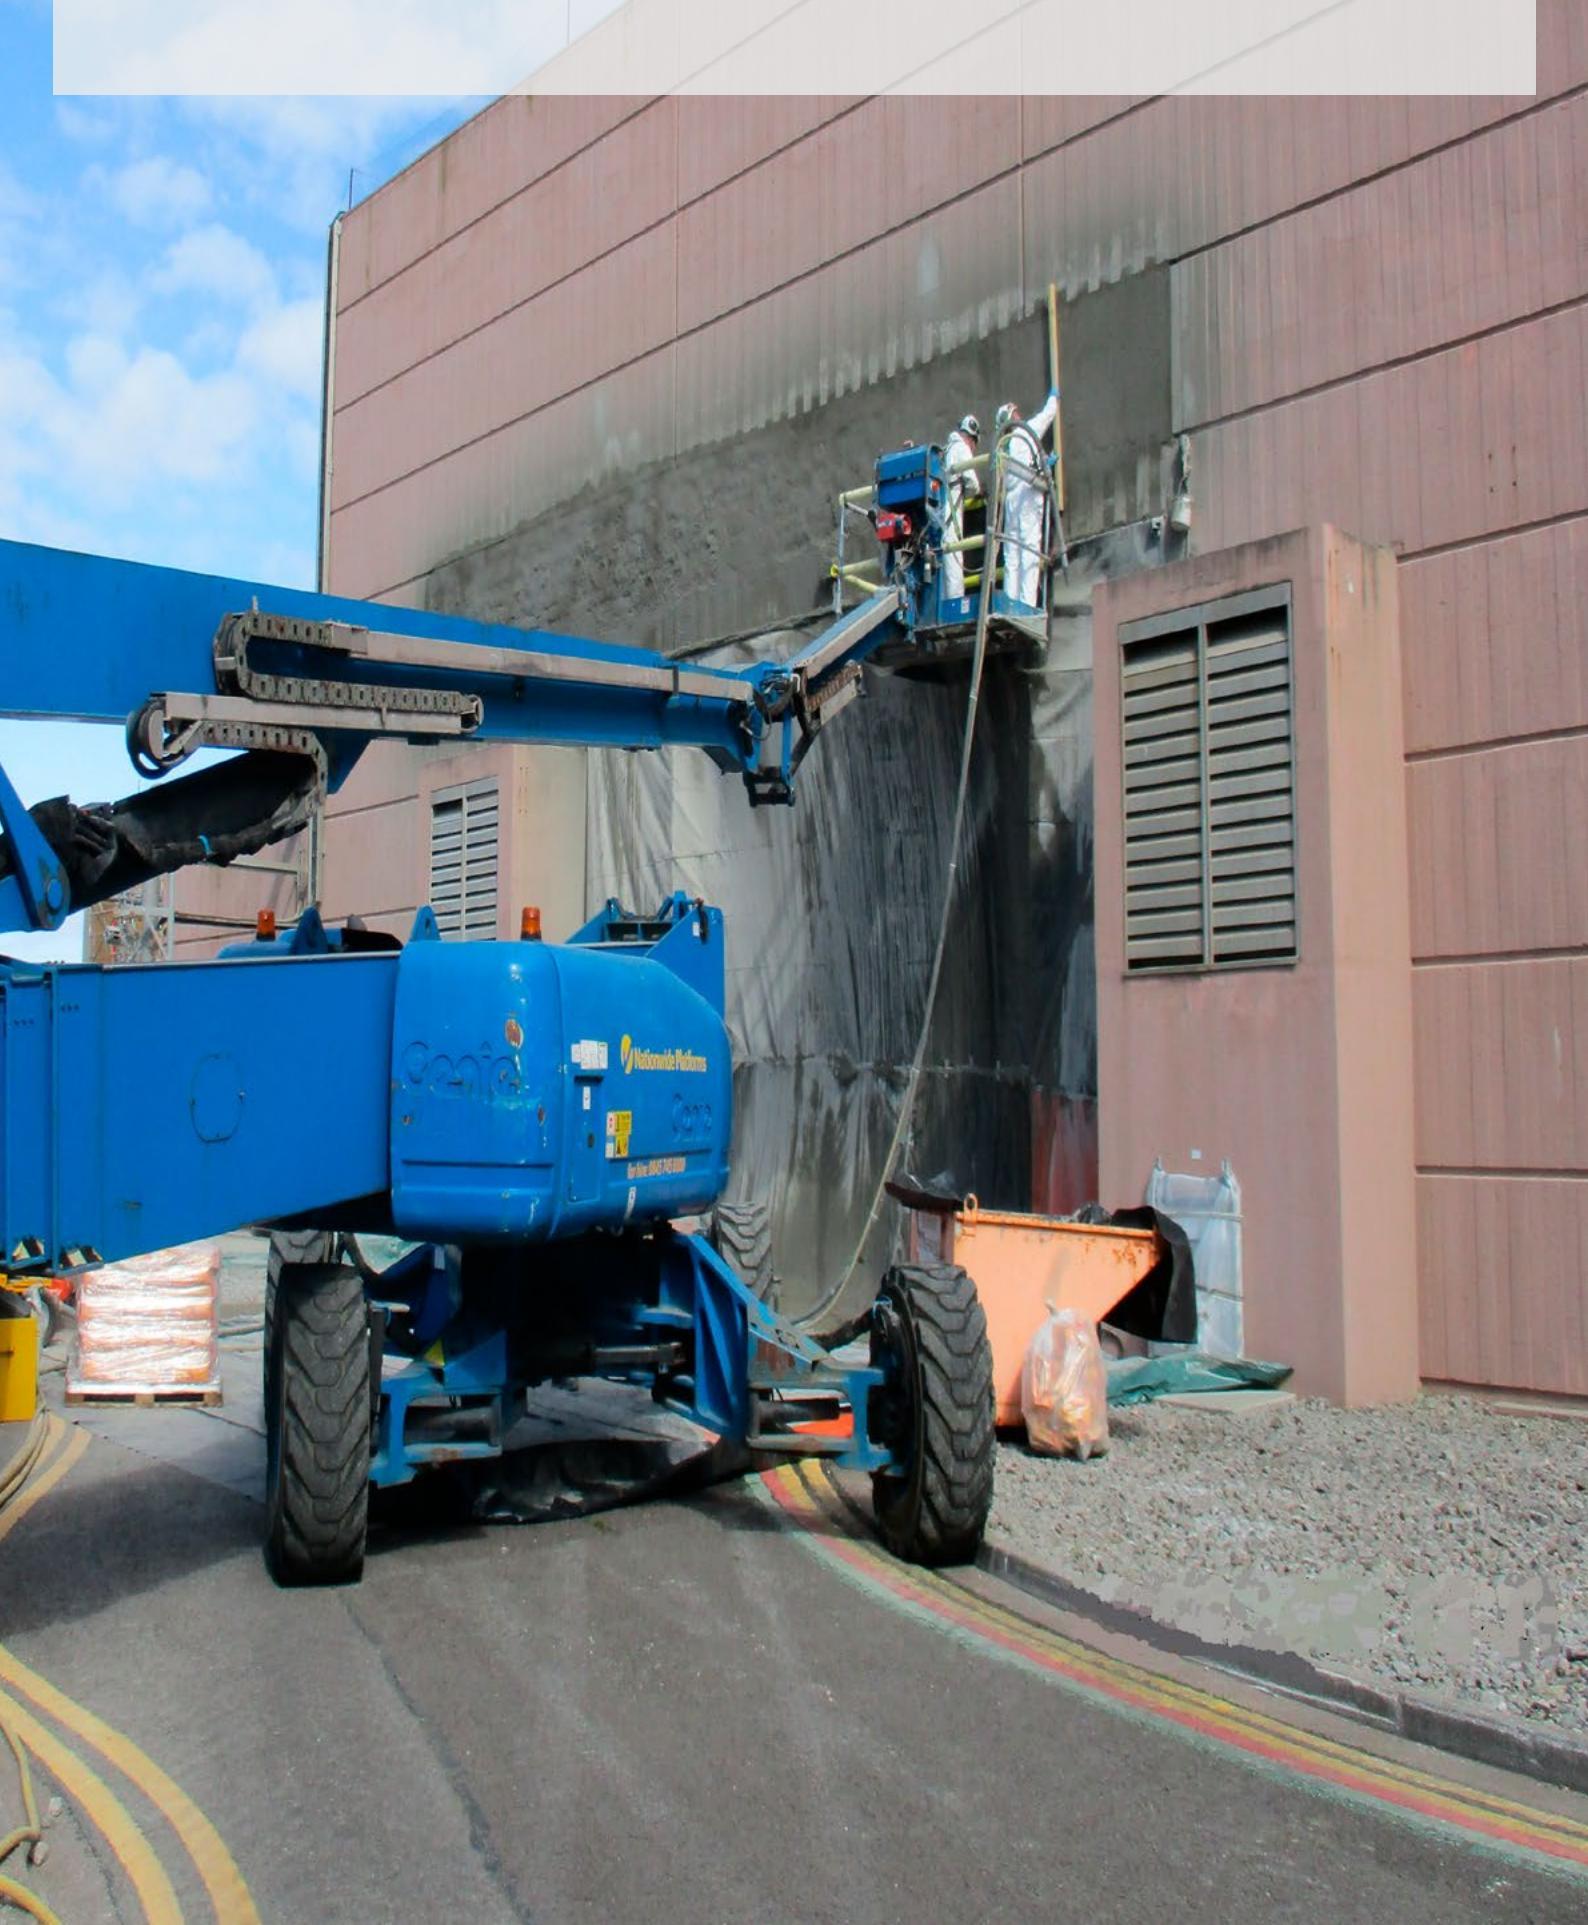
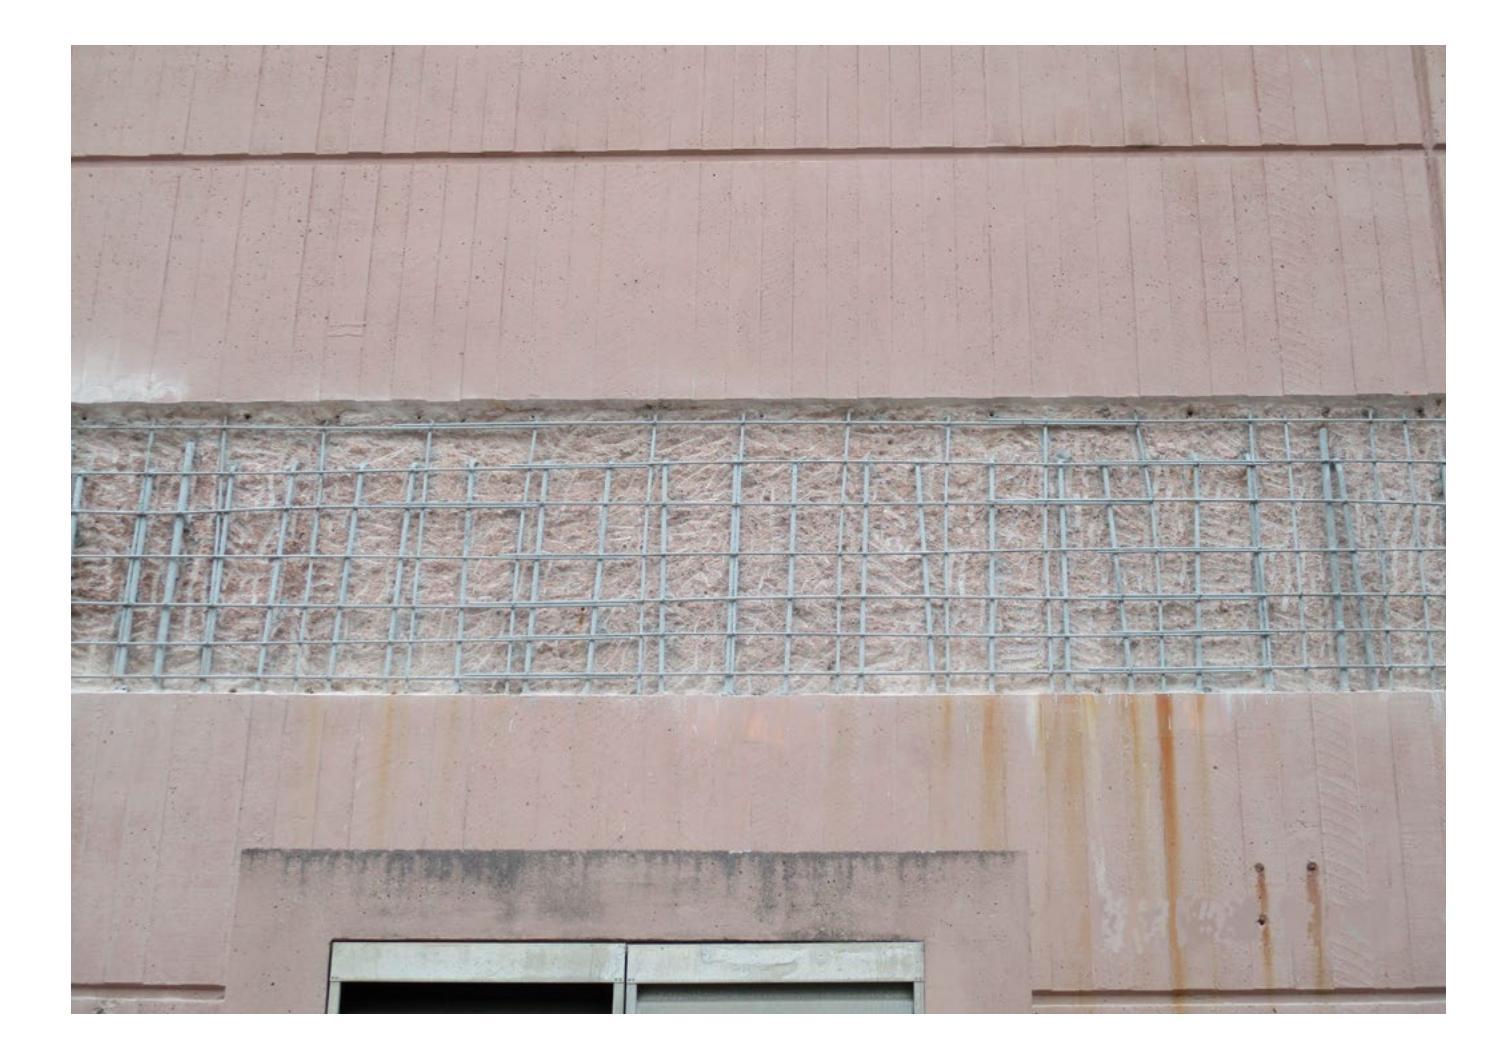
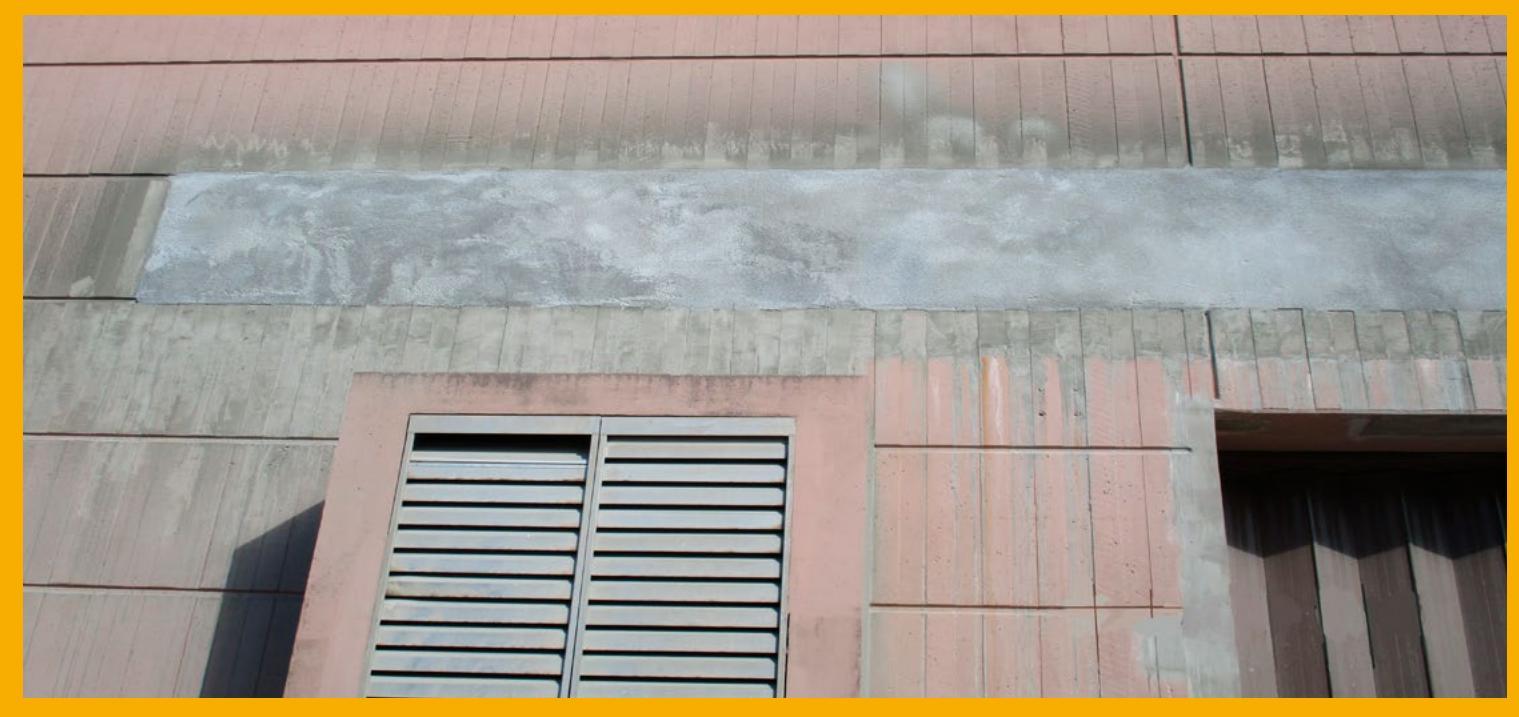
Environmental exposure had caused significant concrete spalling to an area of the Gas Turbine House at the Power Station. The repair was required to mitigate potential health and safety issues and ensure plant reliability.

Due to the size of the repair, and the requirement for business operations to continue unaffected at the Power Station, SikaCem 133GP Gunite, a cement-based, polymer-modified sprayable grout, was specified.

To complete the repair, the area was broken out using mechanical means. This was due to the sensitive nature of the site. A steel rebar specification implemented. Steel was fitted, secured and protected using a Sika steel protection system.

The remaining concrete thoroughly cleaned to ensure it was free from dust, loose material and any other surface contaminant. The sprayed concrete was then installed in layers to prevent sagging or slumping. Striking off the Gunite with a straight edge was carried to finish, before the area was coated for an aesthetic finish. An anti-carbonation coating was used to protect the concrete from further carbonation. The work was completed over four days, as part of the 2018 Concrete Spalling Remediation Programme at Hinkley Point B Power Station for client EDF Energy. This followed on from the 2017 programme and has seen over 300 significant repairs completed at the Power Station over a 6- month period.
