# TECHNICAL INFORMATION SHEET

## Cracks in mineral render finishes and best practice

Cracks in mineral render and best practice  
December 2025, Version 01

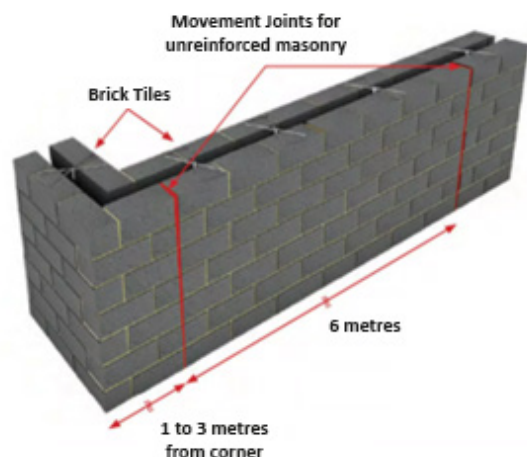
Vertical cracks are commonly caused by the lack of movement joints, whilst cracks coming diagonally from windows/doors or following the blockwork coursing are caused by the lack of bed joint reinforcement in these areas.

Movement joints should be introduced into the structure as recommended by the designer/brick/block manufacturer and in accordance with the guidelines offered under BS 5628 - Code of practice for design of joints and jointing in building construction. As a guide these are generally placed at 6m centres and within 3m of a corner.

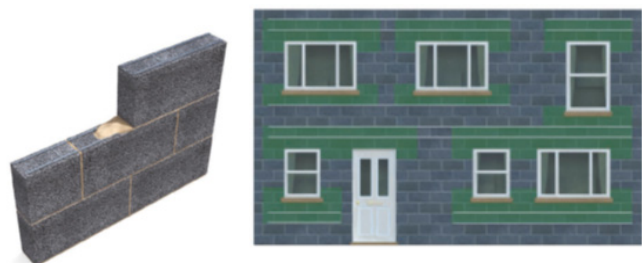
Typical Bed Joint Reinforcement and TV10 Mesh locations (minimum requirement)

Cracking of the substrate can be greatly reduced by using bed joint reinforcement.

Reinforce one block course above the lintel and below the sill, with an additional chord one block apart. Extend the reinforcement a minimum of 500mm past opening or where openings are closer together, to create a continuous chord.

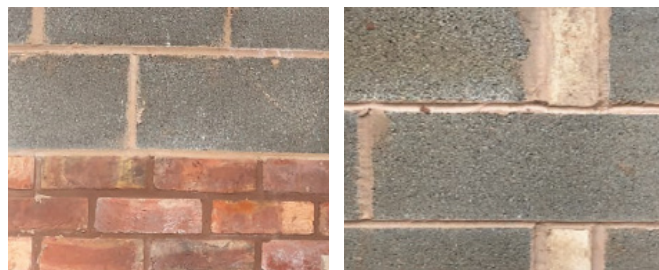
The use of different density materials will generally result in differential movement occurring in the substrate. This will require the use of **Sika TV10 mesh** embedded within the render.
