REFURBISHMENT STRUCTURAL STRENGTHENING WITH SIKA SYSTEMS

BUILDING AND CIVIL ENGINEERING STRUCTURE CASE STUDIES

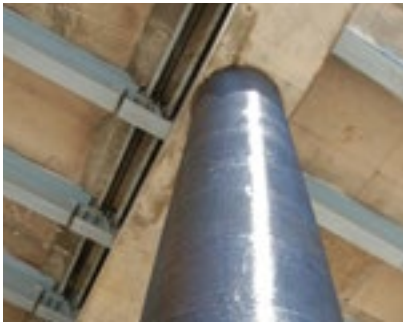
COLUMN STRENGTHENING

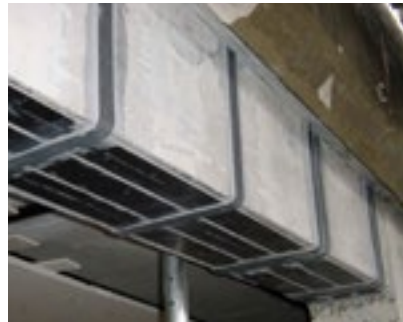
BEAM STRENGTHENING

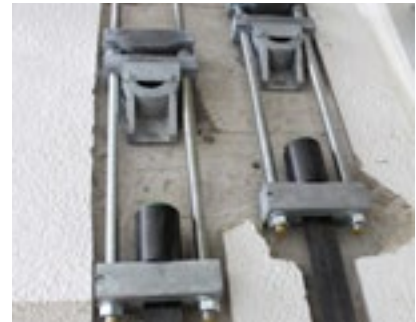
PRE-STRESSED STRENGTHENING

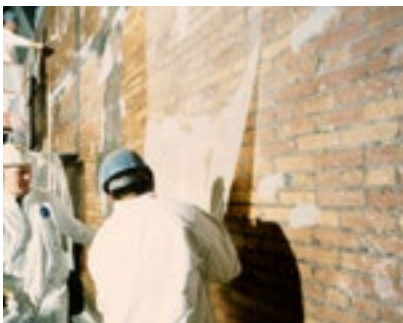
SEISMIC UPGRADING /EARTHQUAKE DAMAGE REPAIR

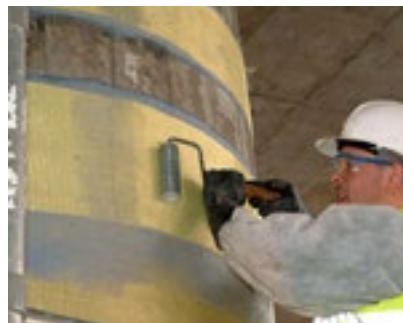
INCREASING IMPACT RESISTANCE

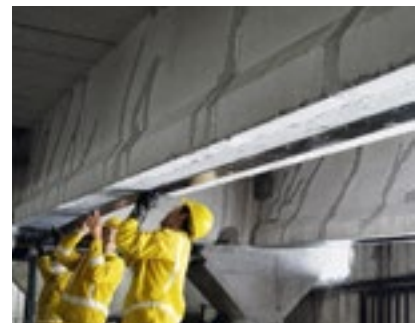
CRACK PREVENTION/REDUCTION

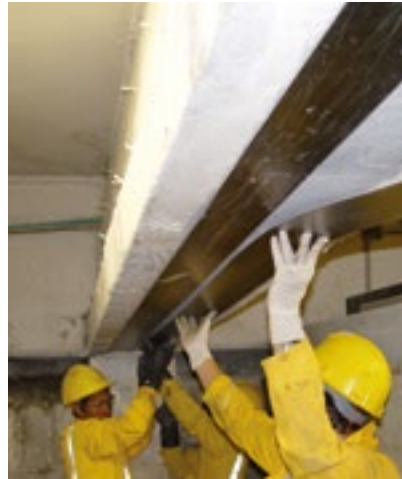
The Sika CarboDur® System is the most widely recognized and established carbon-fiber-reinforced polymer (CFRP) strengthening solution available worldwide. It consists of Sika CarboDur® CFRP plates and rods, together with the structural epoxy resin based adhesives Sikadur®-30 and Sikadur®-30 LP. This simple, tested and well proven, highly durable system has outstanding performance. With the Sika CarboHeater curing times can be accelerated and down time minimized, even at lower temperatures.

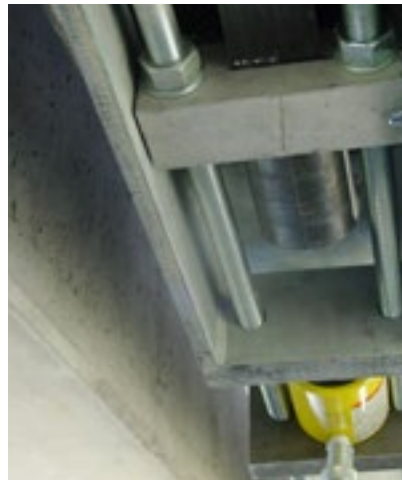
Post-tensioning: a force is applied to create permanent stress in a structure, so that it can withstand load more efficiently or with less total deflection. In conventional post-tensioning, the load is put on steel tendons within the concrete structure, however with the Sika CarboStress® system, the advantages of the Sika CarboDur® CFRP plates and post-tensioning techniques are combined to form a unique active external strengthening solution.

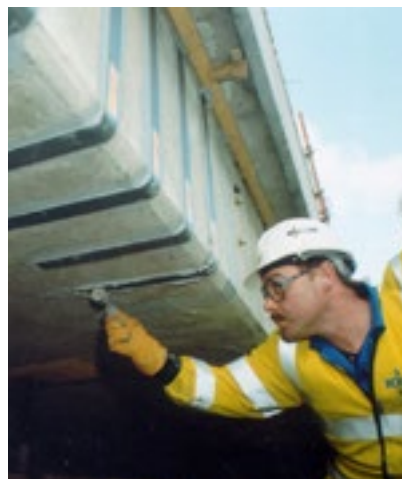
The shear capacity of concrete beams can be increased by the external applied Sika CarboShear L-shaped profiles. Installation is fast and easy, excellent anchorage is assured and no drilling through the top slab is required.

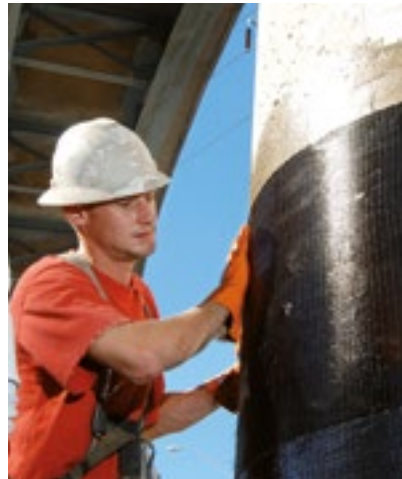
The SikaWrap® fabric strengthening system consists of woven or stitched, unidirectional, carbon and glass fibre fabrics and Sikadur® impregnating resins. This system provides a wide range of solutions to meet different demands on many different types of projects. The installation is extremely flexible and accommodating of different surface planes and geometry, making this a very multifunctional material for many applications including confinement, shear, seismic upgrading and weak substrate strengthening.

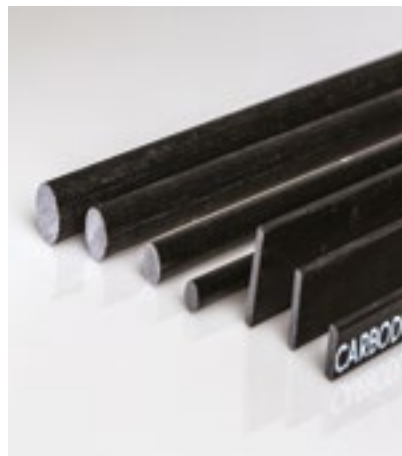
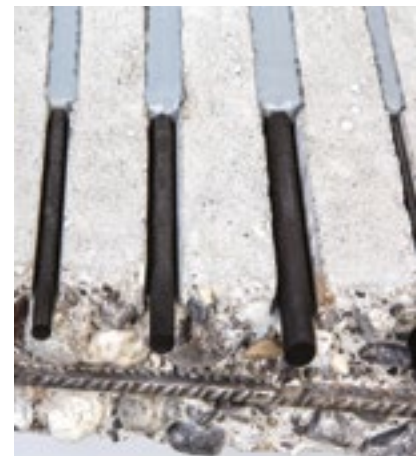
The embedding of Sika CarboDur® pultruded rods or plates into concrete, timber or masonry substrates has many advantages:

- Superior end anchorage
- No extra protection necessary as embedded
- No aesthetic impact
- Installation in weak or cracked substrates is possible
- Application is possible on flat and curved substrates
- Available as different profiles (rectangular or round) and dimensions to suit

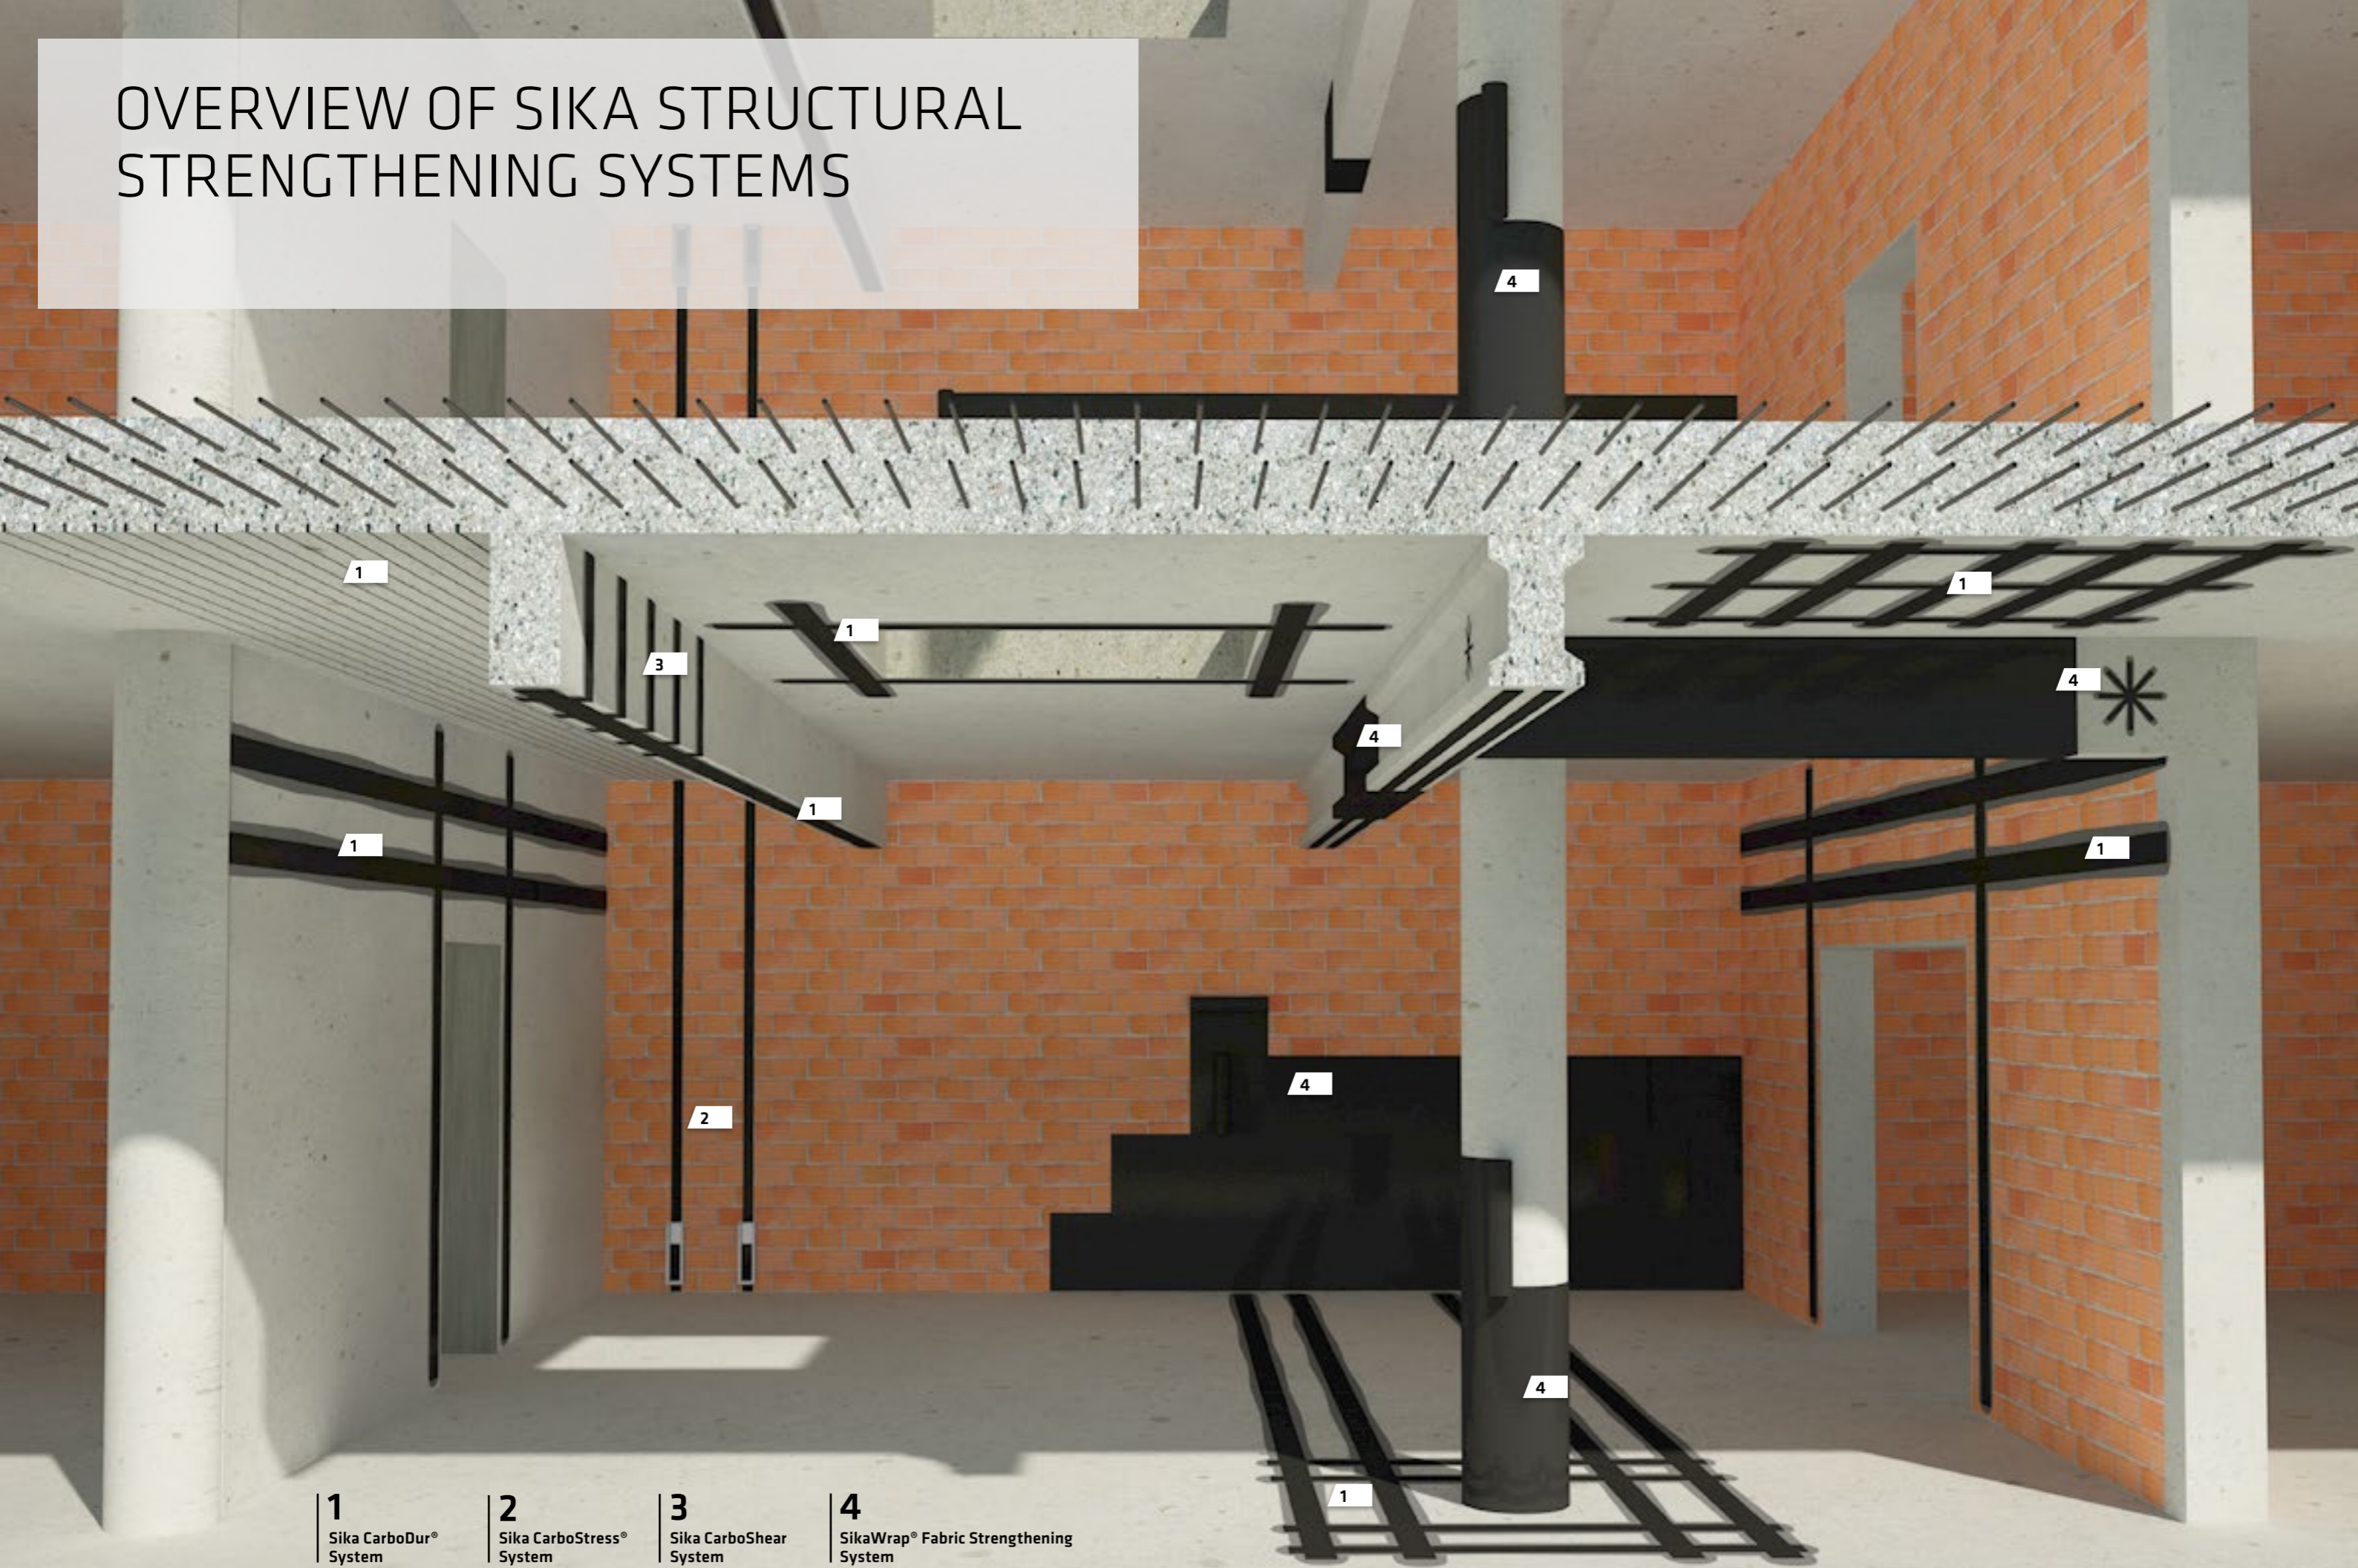
1
Sika CarboDur®
System

2
Sika CarboStress®
System

3
Sika CarboShear
System

4
SikaWrap® Fabric Strengthening
System

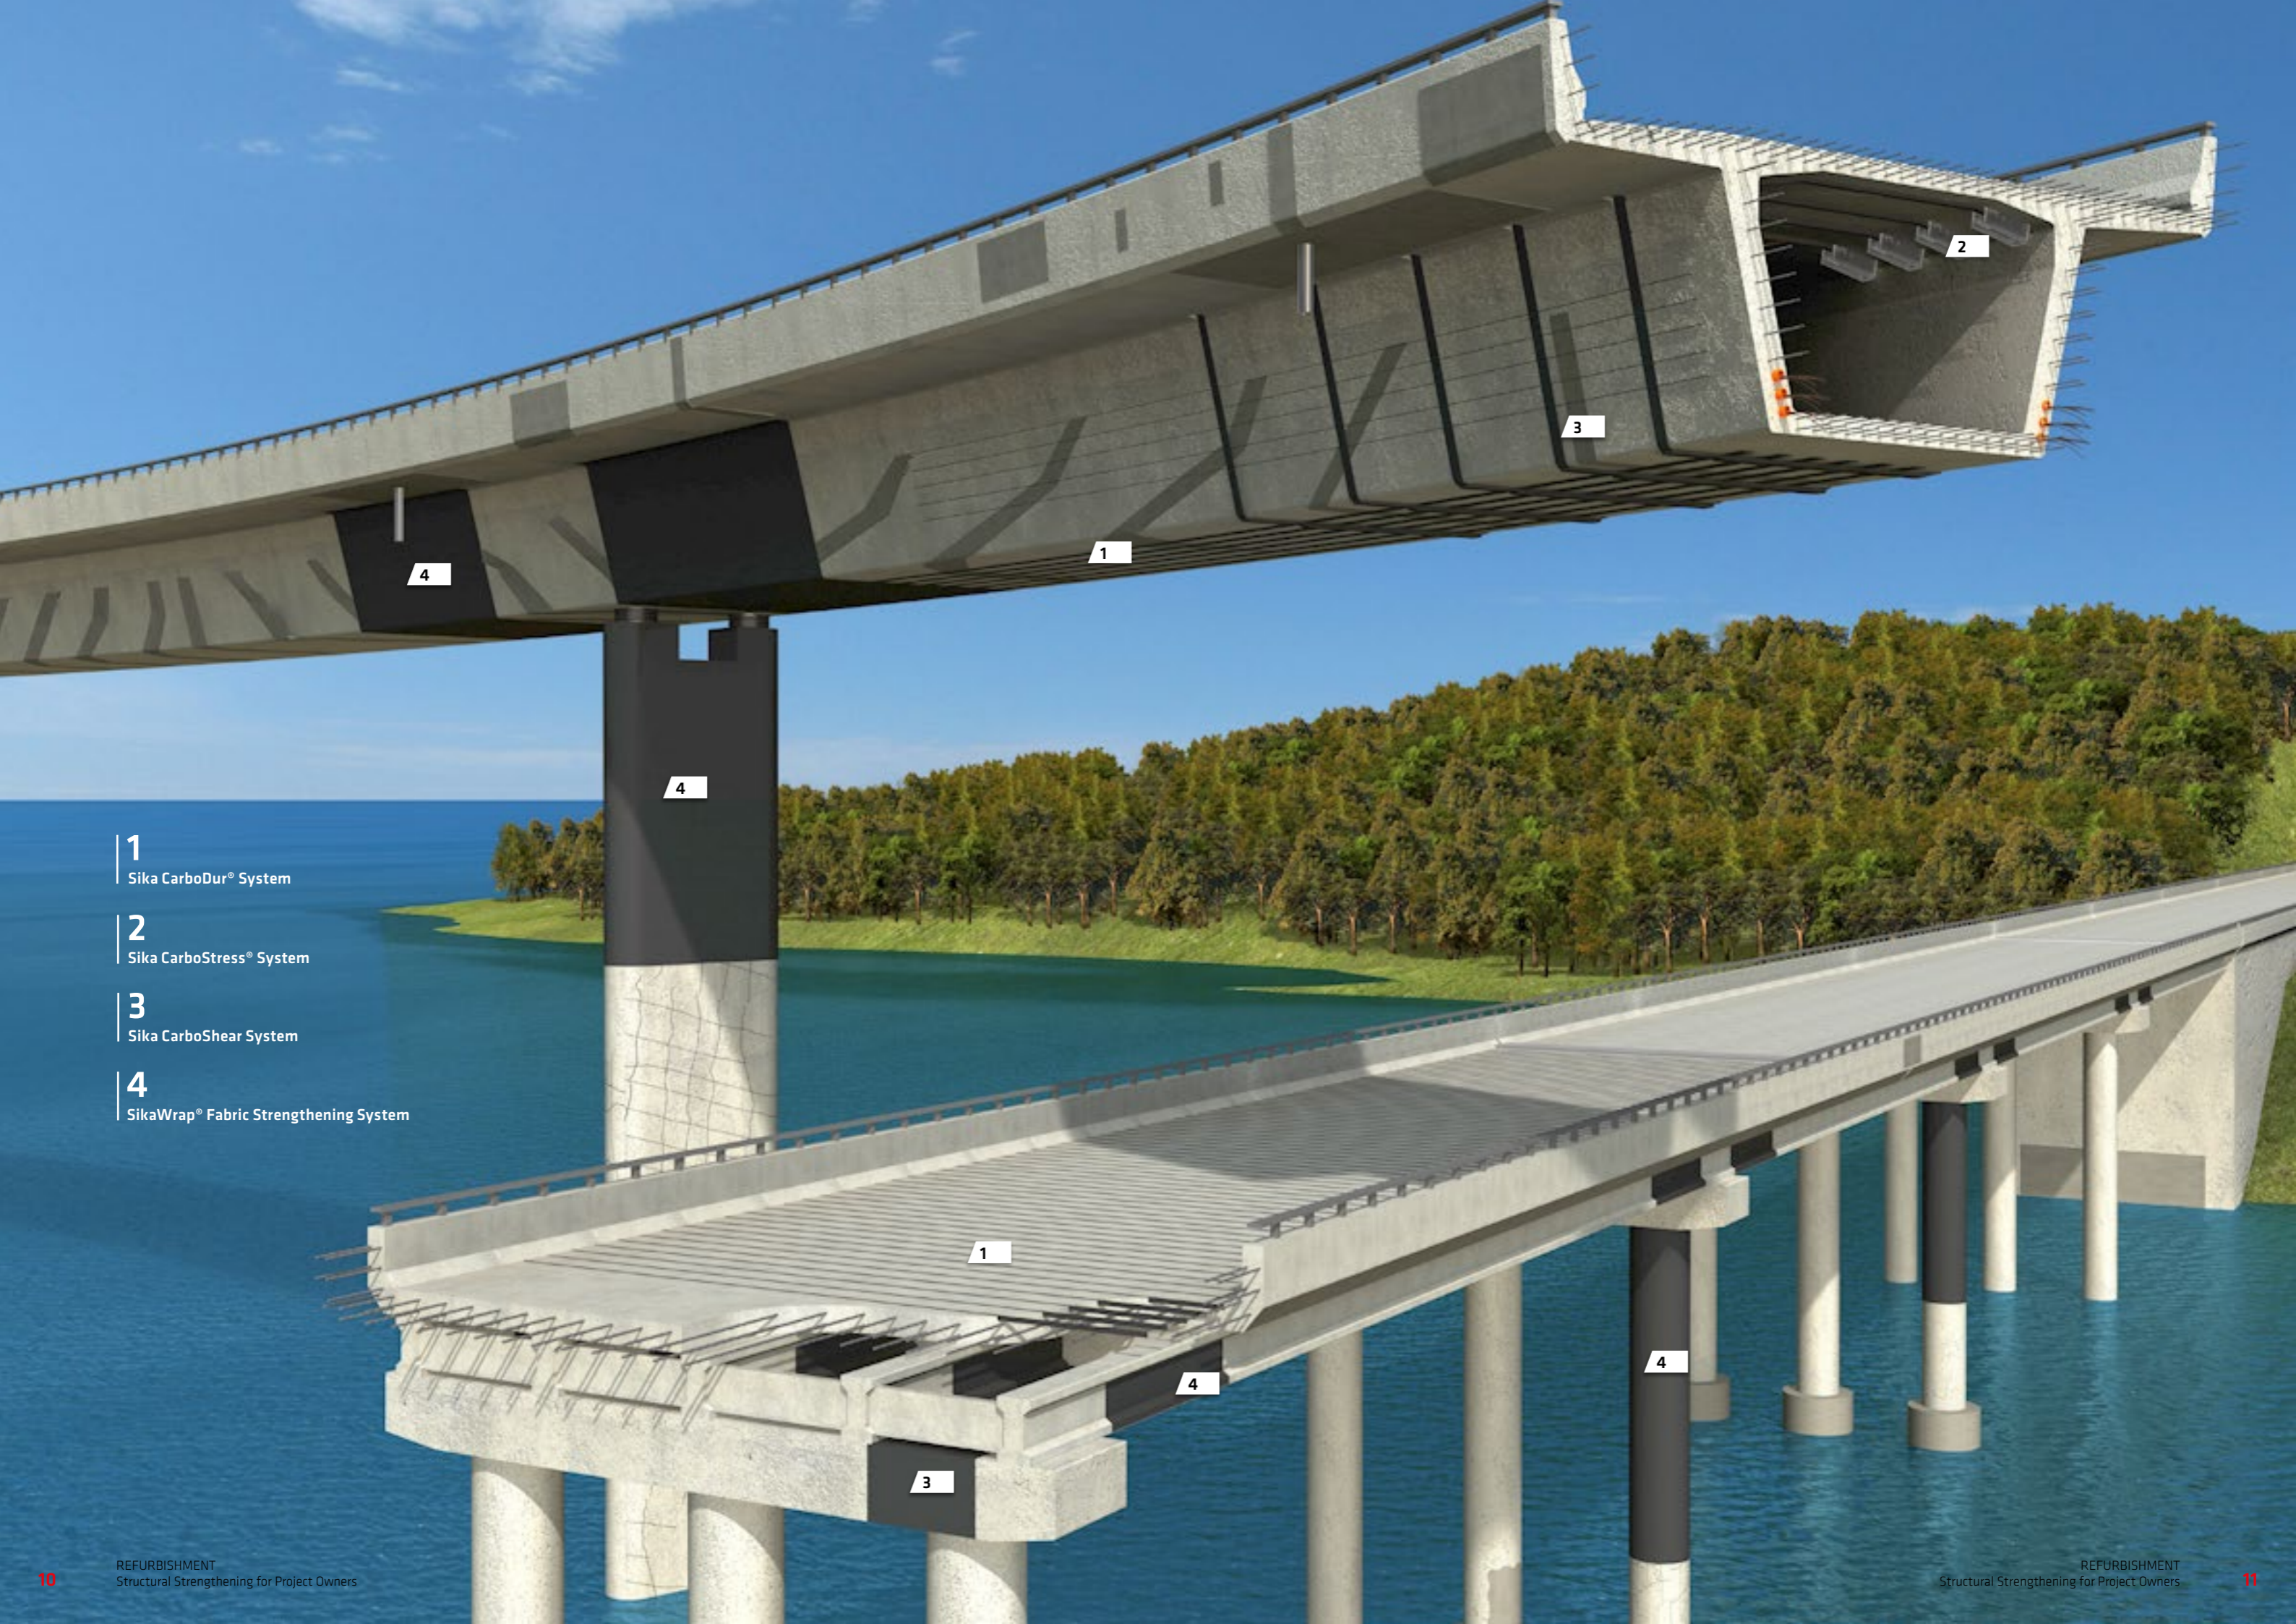
- 1**
Sika CarboDur® System
- 2**
Sika CarboStress® System
- 3**
Sika CarboShear System
- 4**
SikaWrap® Fabric Strengthening System

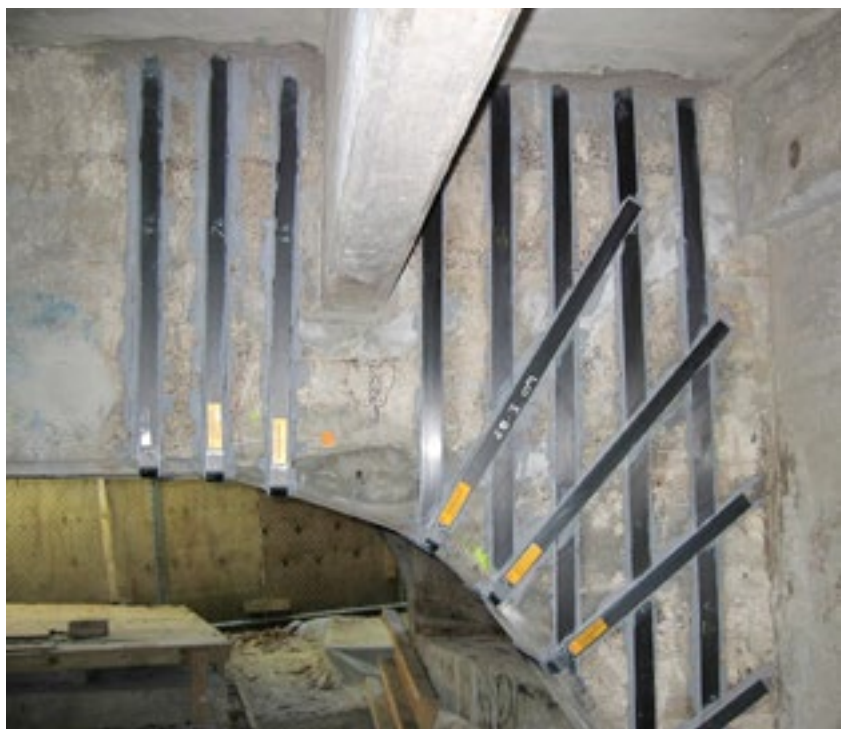
Sika CarboDur® strips and CarboShear L plates bonded to the concrete structure.

Sika CarboDur® CFRP plates were installed on the underside of the reinforced concrete beams to provide additional mid-span movement resistance. The Sika CarboShear L shaped CFRP profiles were then installed, in pairs, around the beams and up into the deck slab to improve the shear performance.

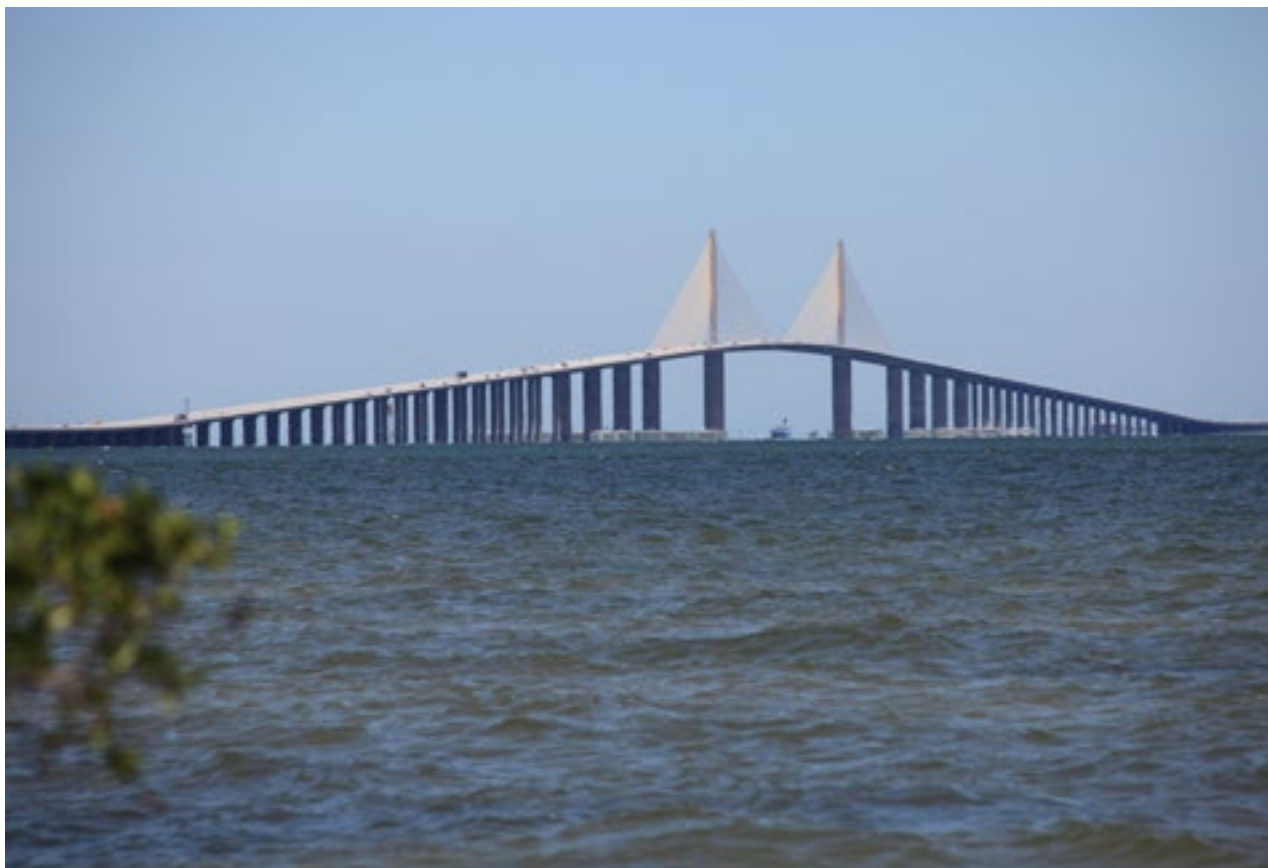
During routine inspections, an increase in shear cracking was observed, mainly on the exterior trestle span girders. The structure needed to be repaired and protected, not only to retain its strength and shear requirements, but also to withstand the aggressive marine environment.

In addition to the repairs by crack injection and damaged concrete replacement, the bridge also needed to be structurally strengthened to carry additional loads. Due to its many advantages over steel and other methods, the SikaWrap® fabric strengthening system was chosen to strengthen the girders. A bi-directional SikaWrap® fabric was installed in several lay-

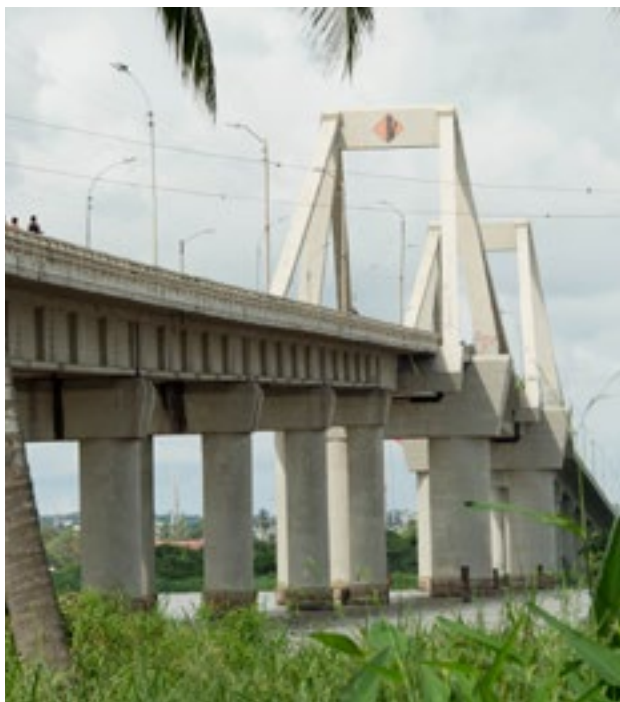
Originally built in the early 1970's to allow development of the Northern Region of the country and to link Barranquilla City with the eastern side of the Magdalena River, it was listed as one of the best concrete structures in the country by the Colombian Ready Mixed Concrete Association in 2006. However after three decades of exposure and service in this aggressive environment, the bridge was completely refurbished to repair areas of spalling concrete due to reinforcement corrosion, and also areas eroded with the loss of coarse aggregates from the columns in and just above the river level.

The refurbishment was undertaken in several stages in 2006 and 2008, and it was also decided to strengthen it in 2011. The repair works included removal of weak concrete, cleaning and protection of exposed steel reinforcement, concrete replacement with SikaTop® and EpoCem® systems after crack injection, steel jacketing around the columns, plus overall protection with an impregnating corrosion inhibitor and a protective coating.

Few years after the initial concrete repair works were completed shear cracks were noticed in the beams and the requirement for structural strengthening was decided by the Engineers. After sealing and filling the cracks with Sikadur® injection resin, the substrate was prepared and a lightweight SikaWrap® fabric strengthening system was applied in two directions and finally the areas were covered with a SikaTop® coating.

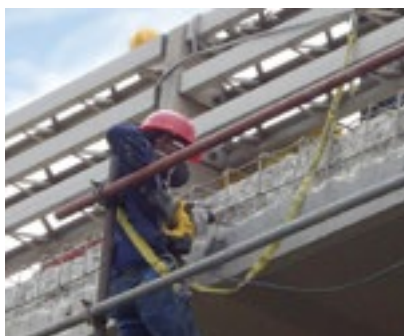
Substrate preparation

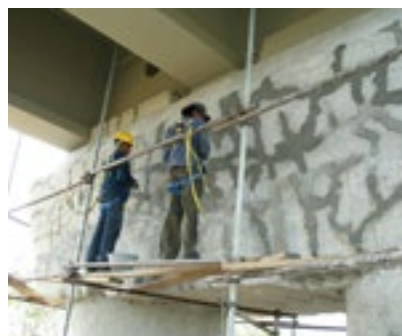
Repair

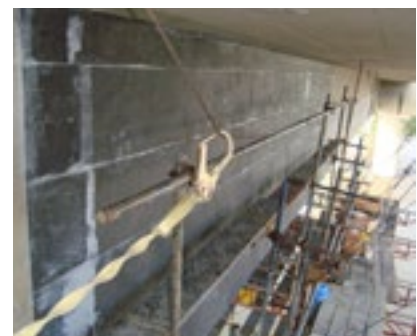
Strengthening with SikaWrap®

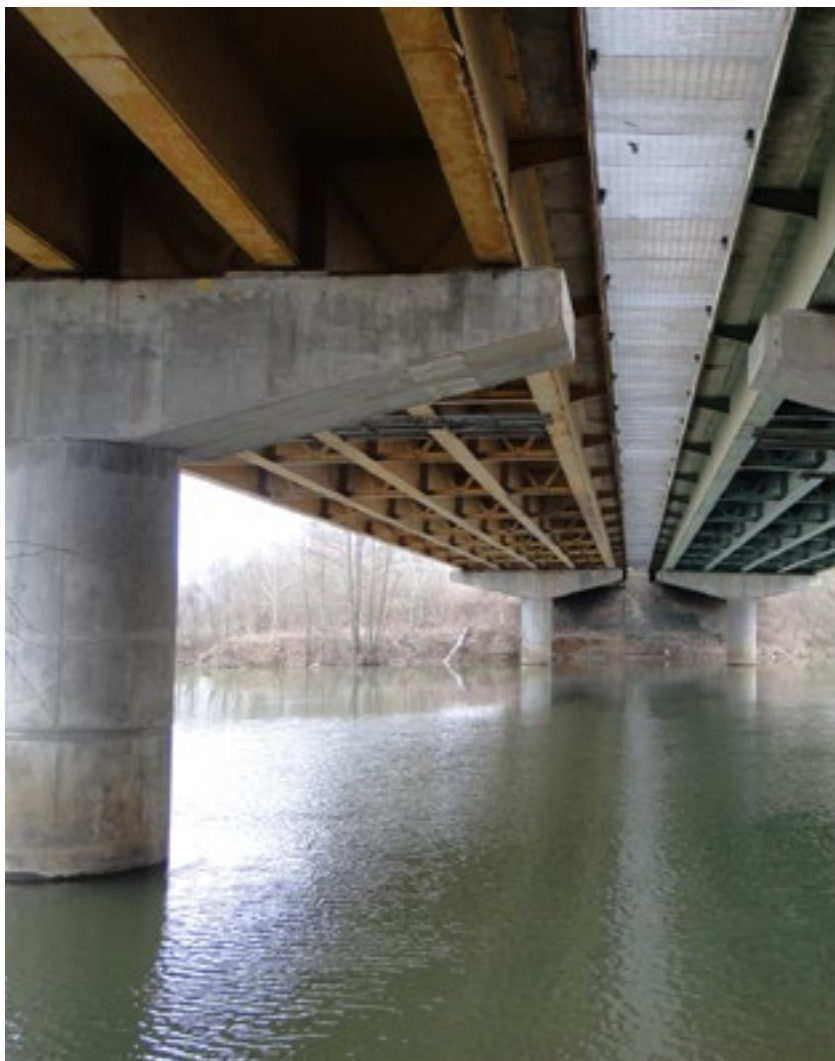
Two layers of Sika CarboDur®

CarboDur® system. After the steel substrate was cleaned and prepared by abrasive blast cleaning, the prefabricated CarboDur® CFRP plates were then immediately bonded to the steel surface with Sikadur® structural adhesive. With these strengthening measures, the mechanical characteristics of the structure were increased and the amplitudes of stresses due to movement were reduced; thus the service life of the bridge was significantly extended. This was the first experience in France of strengthening this type of structure with bonded CFRP.

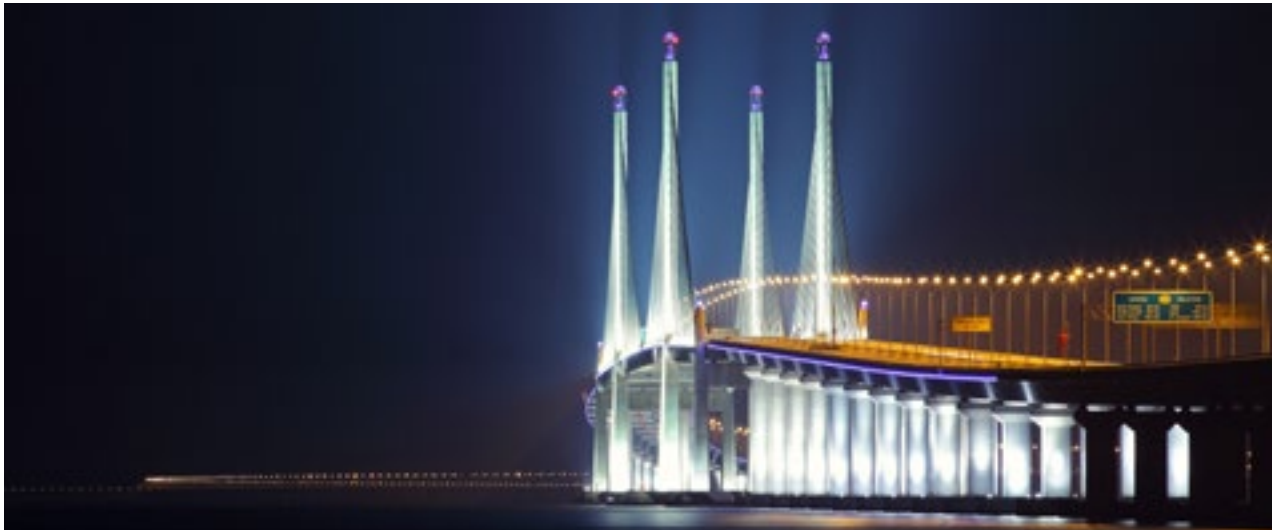
Installation CarboDur®

The damaged concrete was removed and the reinforced concrete beams were repaired with a SikaTop® concrete repair System and SikaGrout® poured concrete. The beams were then strengthened to the performance levels required by the

Engineers, using a layered build-up of the Sika CarboDur® CFRP System. Finally, all of the exposed concrete and CarboDur® plate surfaces were given a protective Sikagard® coating to protect them against UV light and future attack from the aggressive marine environment respectively.

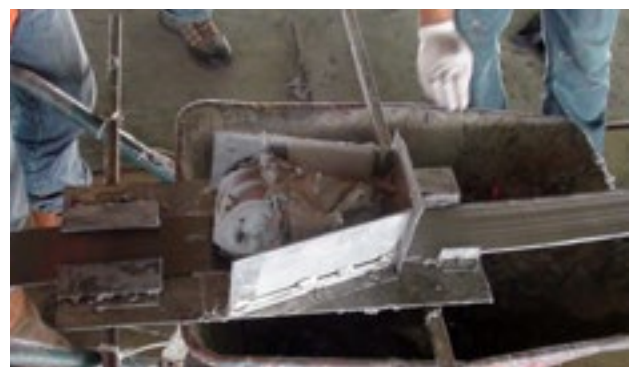
Coating of CarboDur® plates with Sikadur®

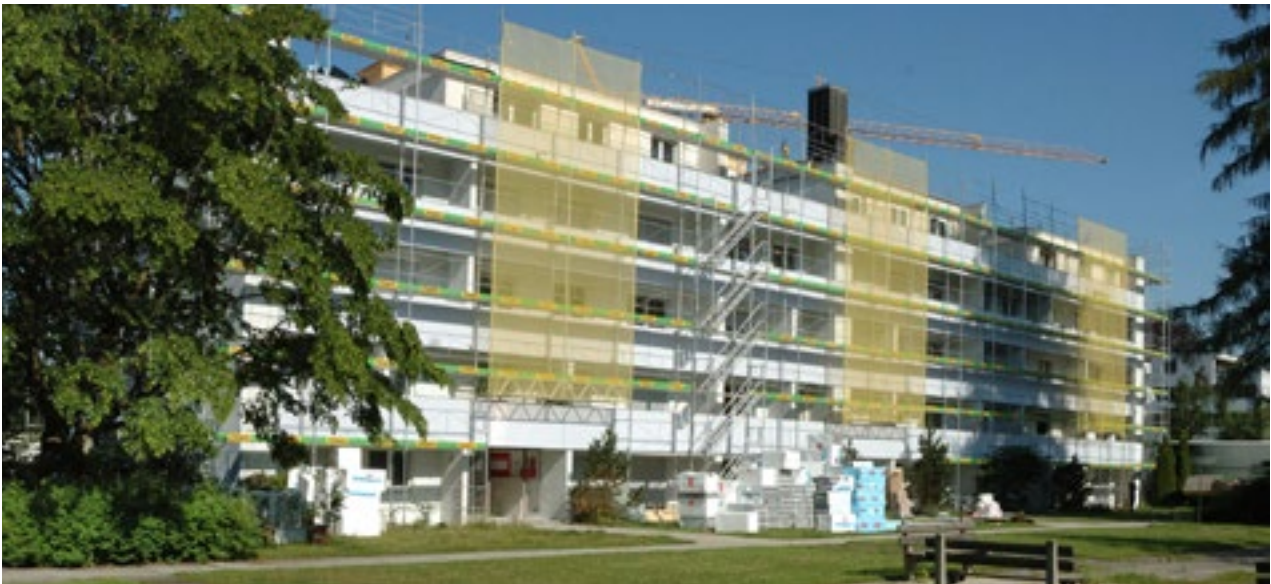
Anchorage of Sika CarboStress System

The Sika CarboStress® system was selected to achieve the necessary seismic resistance on the structure. This consisted of post-tensioned Sika CarboDur® CFRP plates anchored into the substrate. In the three stairwells of the building, a total of 12 Sika CarboStress® tendons were installed. Since these Sika CarboStress® tendons were relatively small, flexible and could be

assembled on site, the installation of the system was straightforward, even in the limited space constraints of the stairwells. There was also minimal breakout of sound material on site, as for all of the tendons, the dead end was simply anchored into the cellar wall, with the live end assembled in such a way that it transferred the post-tensioning force through a steel element into the floor and subsequently into the wall of the building. With this setup, the walls were quickly strengthened to the necessary standards and without damaging the masonry or adding unsightly bulk and unnecessary weight to the structure.

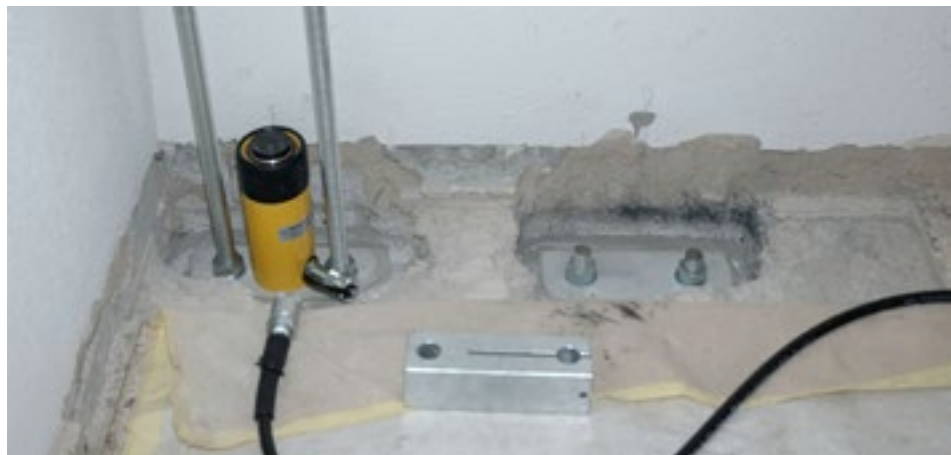
Pressure cylinder

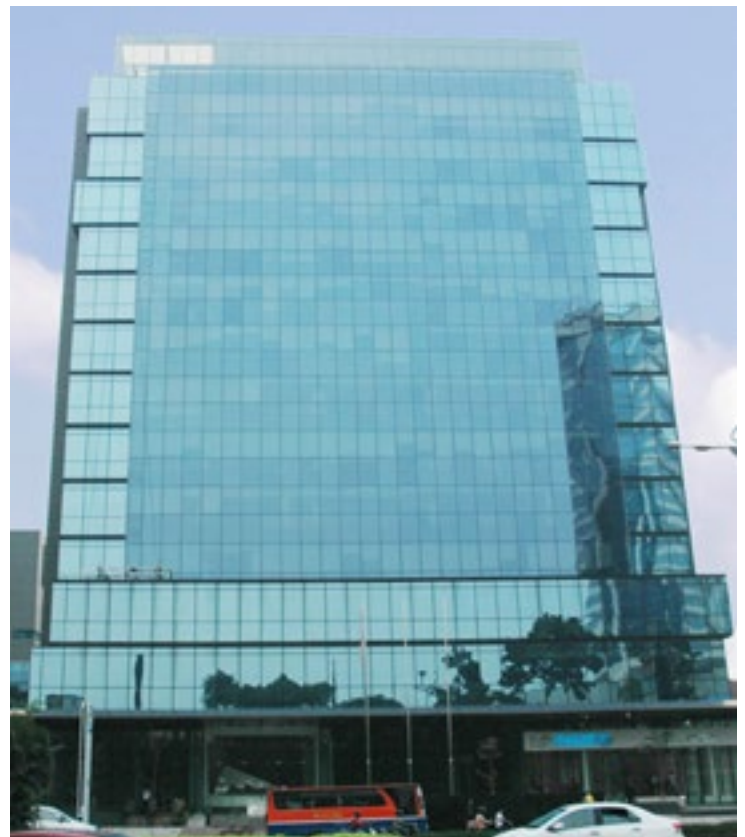
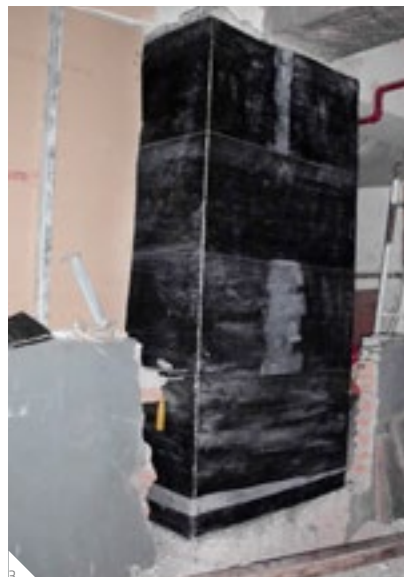
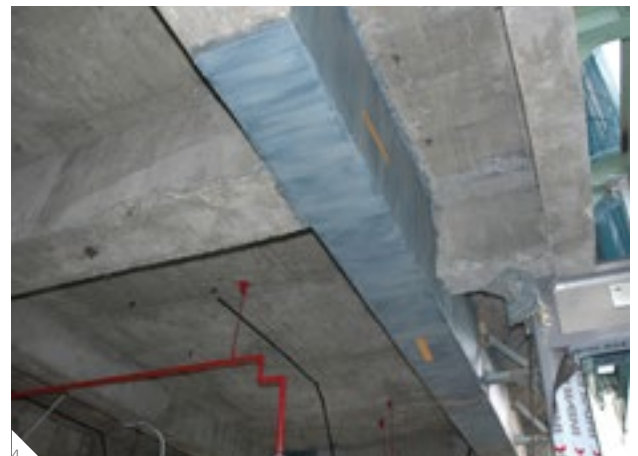
- 1 Beam strengthened without removing wall
- 2 CFRP installed around existing obstacles
- 3 Columns strengthened with SikaWrap® fabric
- 4 Reinforcement of beam with CFRP

The Engineers selected a Sika structural strengthening solution with carbon fiber-reinforced polymer (CFRP) materials, because of its effective performance despite its lightweight characteristics. Furthermore, the Sika systems allowed flexibility on site to overcome any issues and were easy to apply. The columns in the basement and ground floor were strengthened to provide increased confinement with the SikaWrap® fabric strengthening system. The cross beams were then either strengthened in flexure and against shear, or against shear only, by using a combination of Sika CarboDur® CFRP plates and SikaWrap® fabrics, with up to three layers of the fabrics being applied. During the installation works on site unforeseen conditions, including walls that could not be removed and voids in the existing concrete, were found. Another advantage of these Sika strengthening solutions was then that their design can be adjusted accordingly, so the works could still be completed successfully and with minimal break-out or removal of sound materials on site.

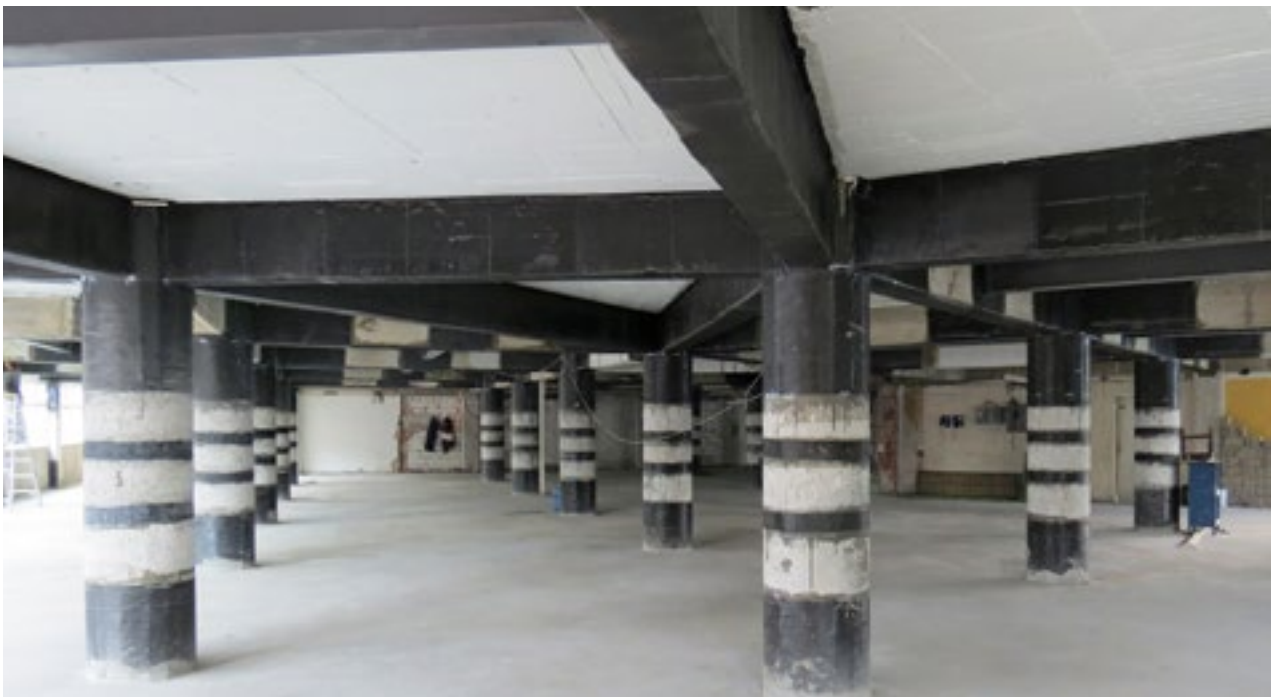
Beams and columns strengthened with SikaWrap®

A number of steps were then taken to refurbish and upgrade the whole building, including additional steel bracing and casting additional concrete, sealing existing cracks by injection and then overall structural strengthening. The beams were strengthened in flexure and shear using the SikaWrap® fabric strengthening system, the columns had continuous Sika CarboDur® CFRP plates installed along their axis over several storeys, then the columns were also wrapped with SikaWrap® fabric to increase their strength and ductility. The complete refurbishment project was easily completed on time due to the lightweight nature and rapid installation procedure for these Sika systems. The weight of the structure was only slightly increased, and no useable area was lost.

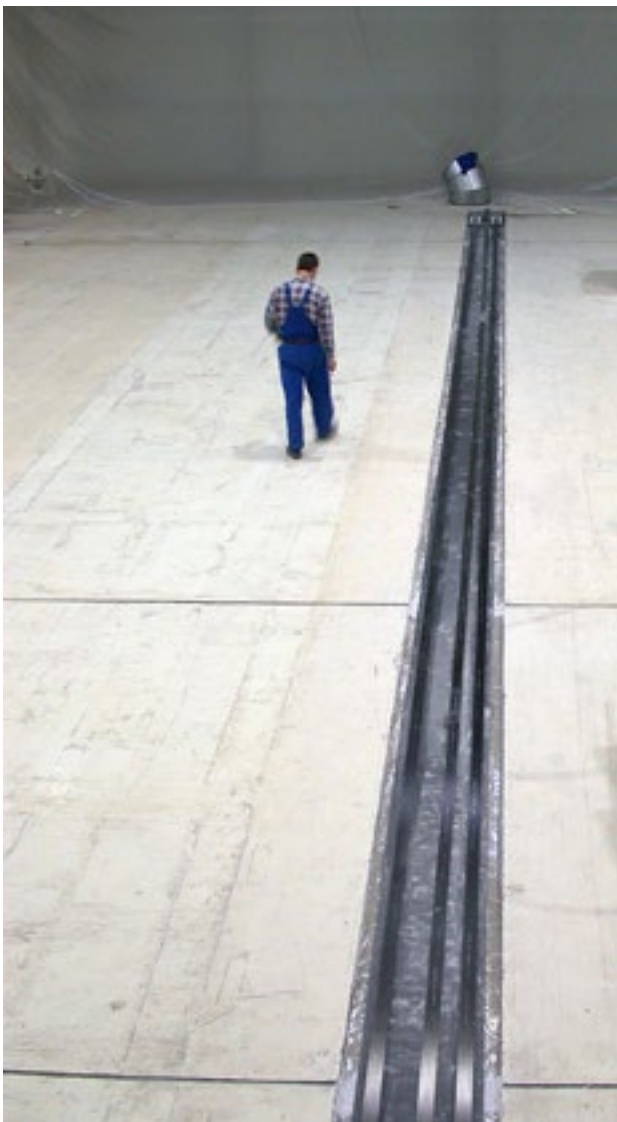
The longest post-tensioned CFRP-plates ever installed

With 29 m this is the one of the longest post-tensioned CFRP plates ever installed in the world.

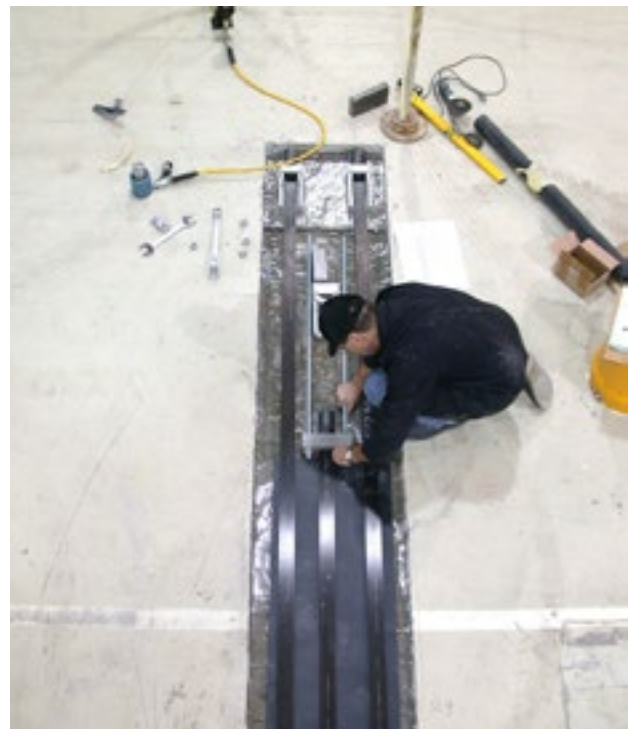
Plate and end-anchorage

System. Three tendons, consisting of CarboDur® plates and special end anchorage heads were installed to produce a united base without joints. The CFRP plates were then encapsulated into the concrete base to protect the system and to make the area ready for use.

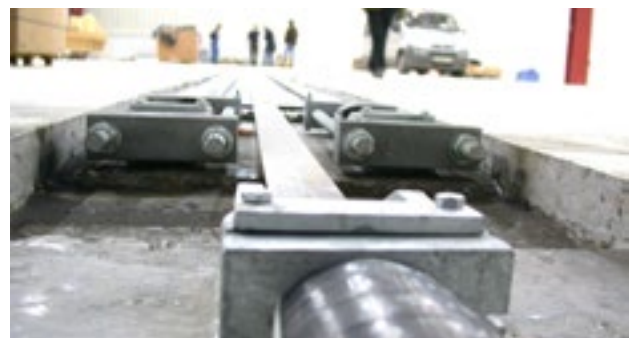
Base channel with post-tensioned CFRP plates

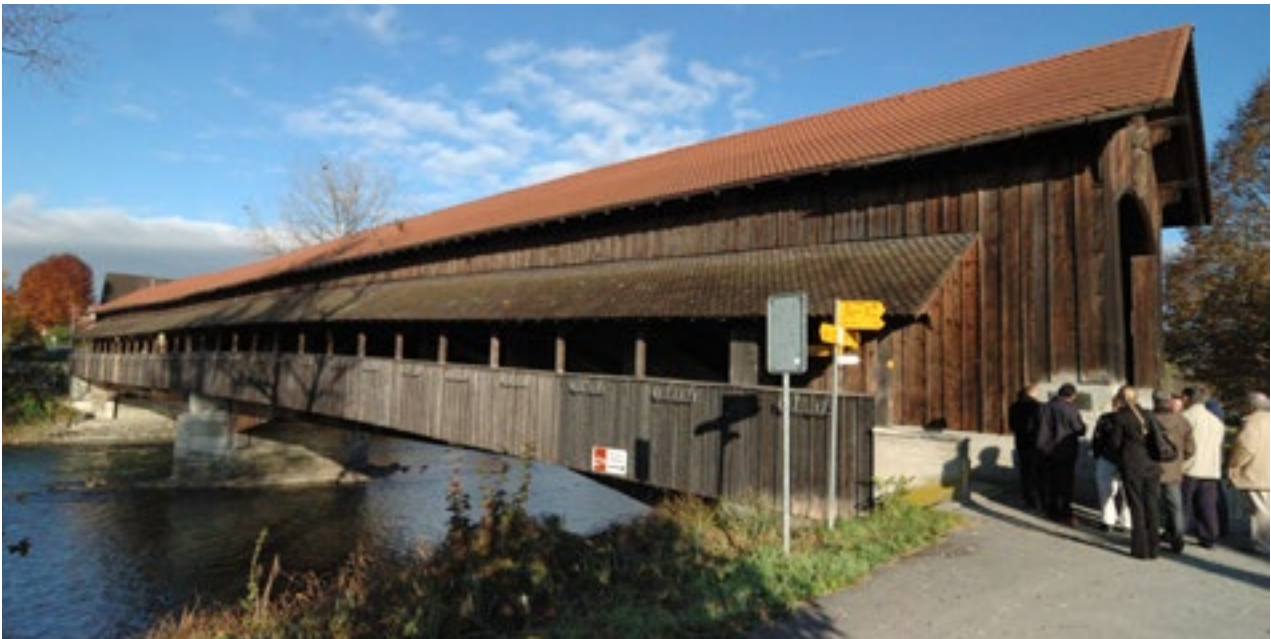
CarboDur® strengthened crossbeam

To refurbish the bridge the deck was removed and rebuilt, and Sika CarboDur® CFRP plates were bonded to the bottom of the crossbeams to reduce deflection. The installed plates were left exposed and uncoated to facilitate inspection and assessment, but to date the installation remains maintenance free.

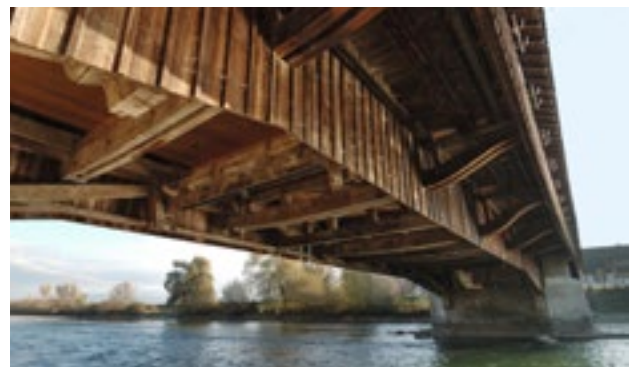
Bottom view of strengthening system
