REFURBISHMENT STRUCTURAL STRENGTHENING WITH SIKA SYSTEMS

BUILDING AND CIVIL ENGINEERING STRUCTURE CASE STUDIES

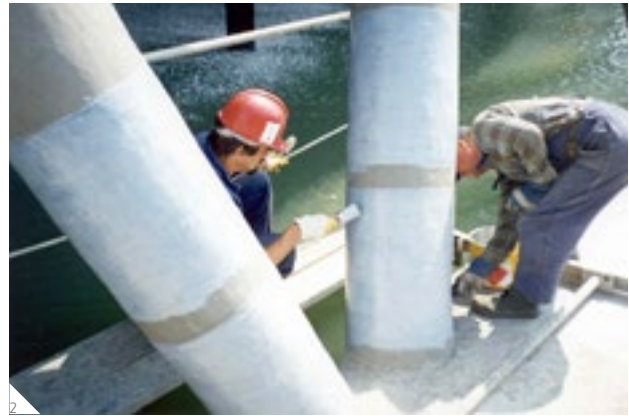
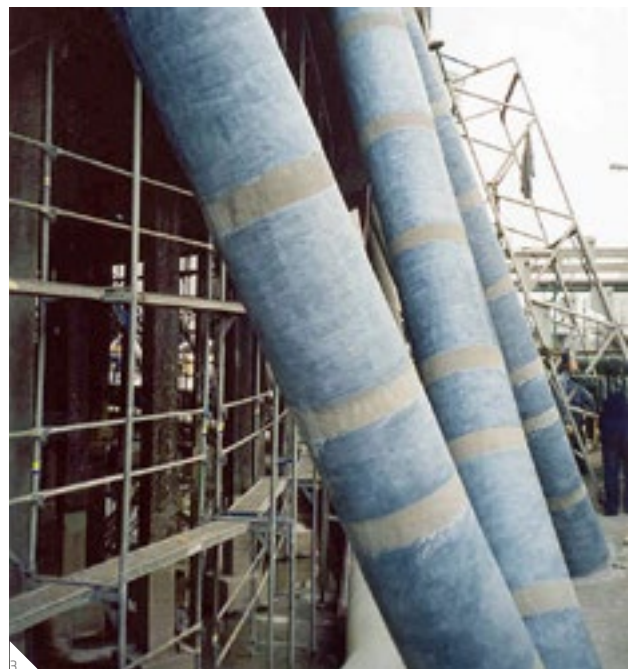
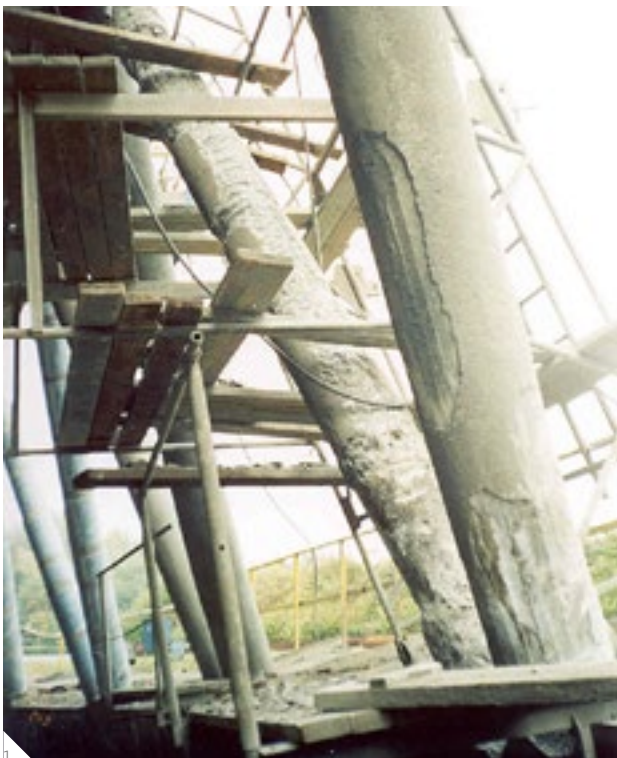
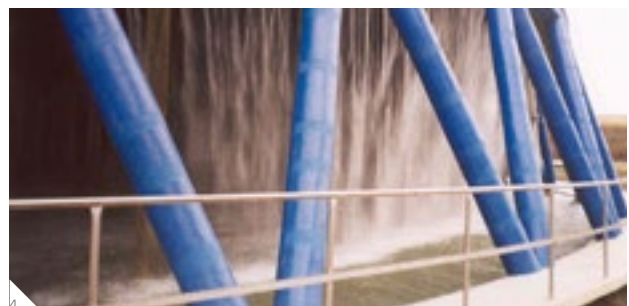
- 1 Damaged columns
- 2 Application of SikaWrap®
- 3 Installed strengthening system
- 4 Coated strengthening system

On 92 of the main supporting columns the concrete had spalled-off over corroding reinforcement in several areas, the steel was then exposed and continuing to corrode and lose significant cross section. The structure therefore now needed not only concrete repair and replacement on the damaged columns, but also a structural strengthening solution to reverse the loss of strength resulting from the corrosion and damage.

After removal of all damaged concrete and preparation of the surfaces, selected columns were repaired with sprayed concrete based on Sikacrete® admixture. The rest of all together 92 columns was then reprofiled with the Sika MonoTop® repair system and sealed with a Sikagard® impregnation. When the repairs were hardened the necessary confinement strengthening was carried out using SikaWrap® fabric in sections. Finally, all of the surfaces were overcoated with a Sikagard® protective coating for improved appearance and additional durability.

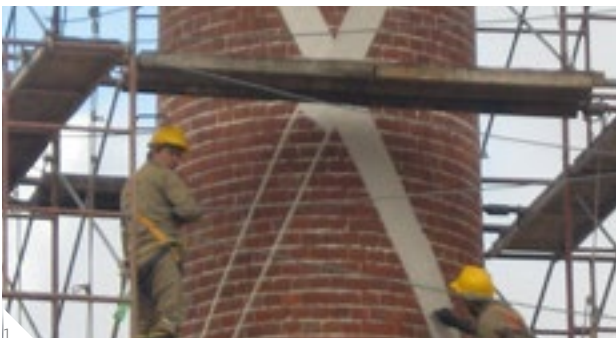
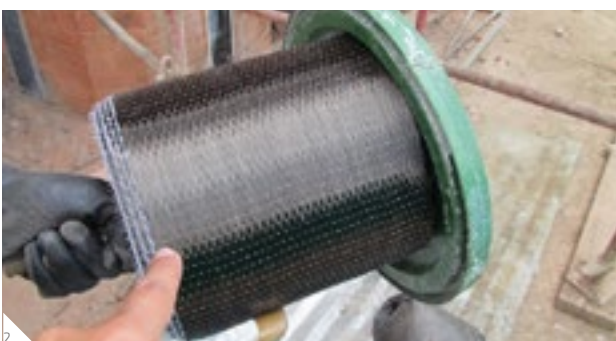
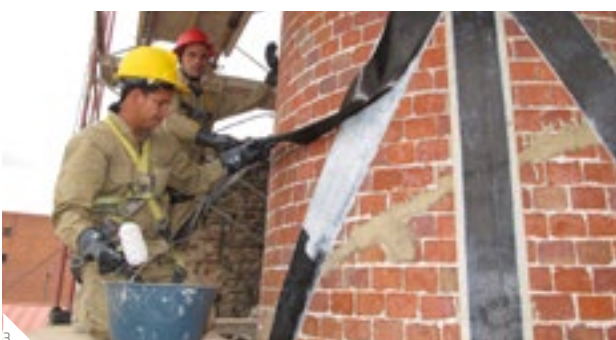
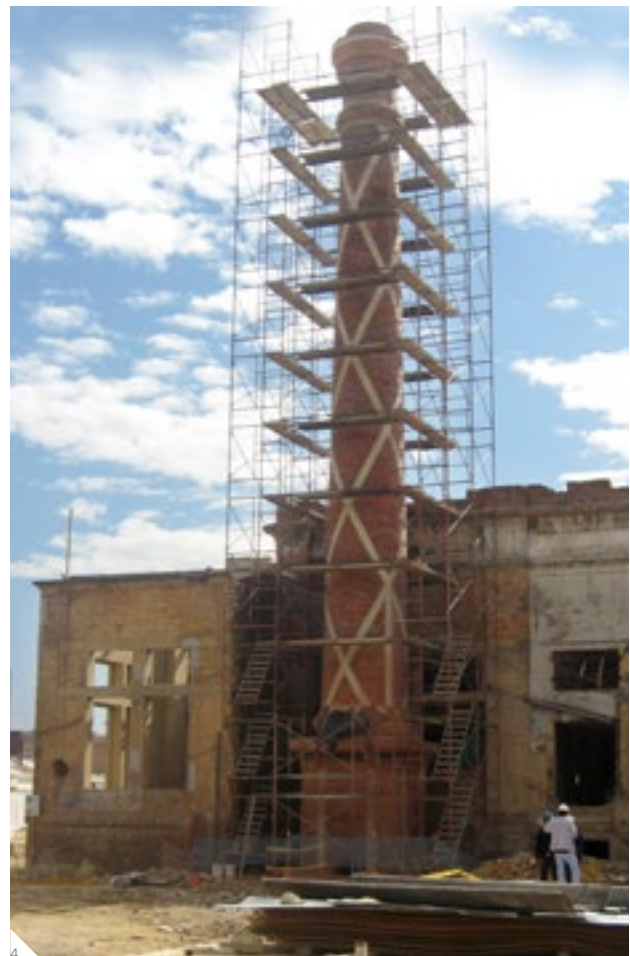
- 1 Substrate levelling
- 2 SikaWrap® roll
- 3 Installation of SikaWrap®
- 4 Coated strengthening system

A complete Sika solution was selected. After cleaning the structure thoroughly, Sikadur® epoxy mortar was applied to level the surfaces and prepare them for application of the SikaWrap® fabric strengthening system. SikaWrap® fabric strips were then cut to size and applied symmetrically, both diagonally and vertically, to improve the strength of the whole chimney structure with a uniform appearance. Finally the whole masonry chimney surfaces were overcoated with an acrylic protective coating.
