REFURBISHMENT MERRION CENTRE MSCP

INTRODUCTION

As the structure approached its 50th anniversary, Curtins Consulting was employed to develop and deliver a refurbishment strategy for the multi storey car park at the Merrion Centre. Curtins have been involved in refurbishment projects for over 50 years. They have experience of large and small, straightforward and complex projects which enables them to develop an approach to give the best value to the client and the team.

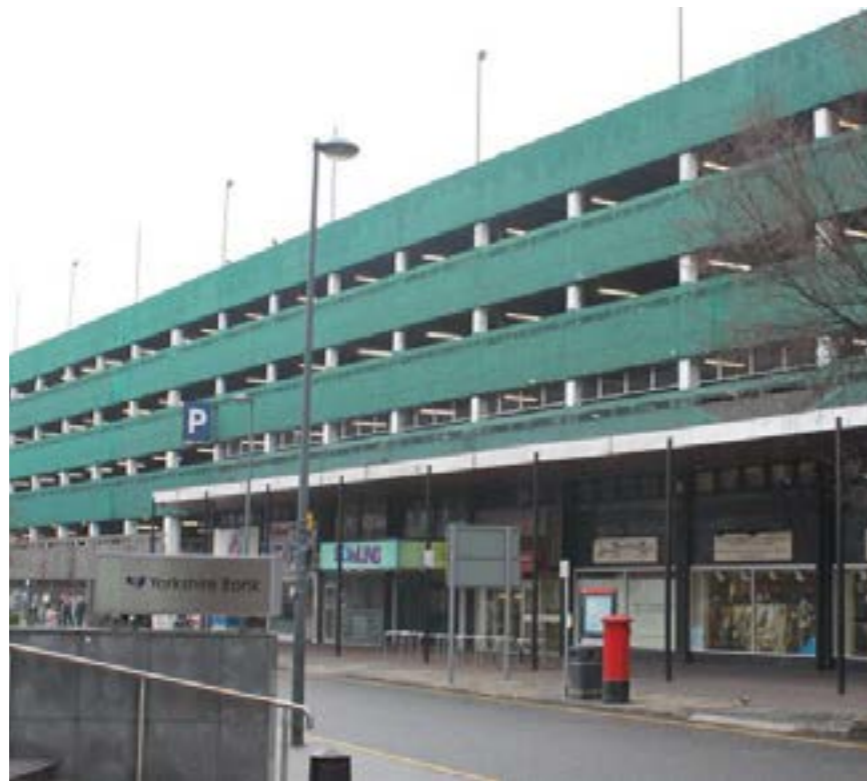
MERRION CENTRE – BEFORE REFURBISHMENT

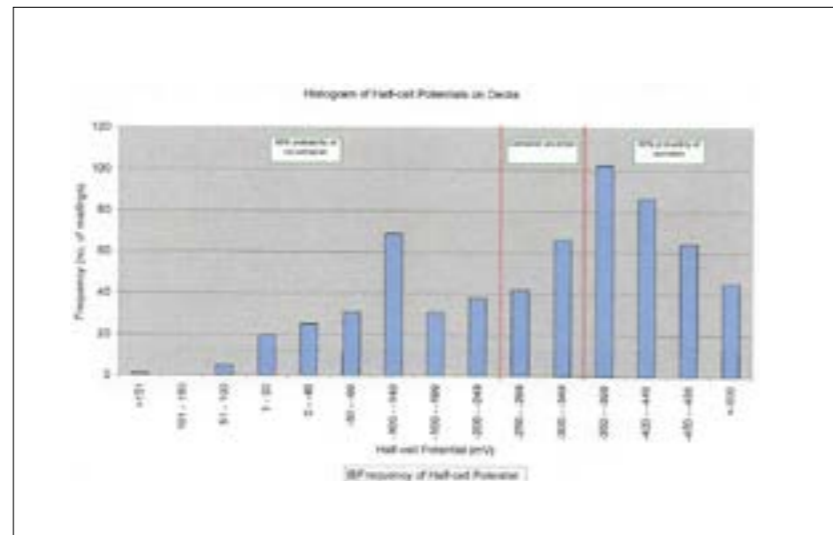
HALF CELL POTENTIAL DISTRIBUTION OF DECKS

The areas which consistently showed the highest chloride concentrations and corrosion potential were over the precast concrete bridge beams. Areas of lower risk were typically the floor slab areas between bridge beams.

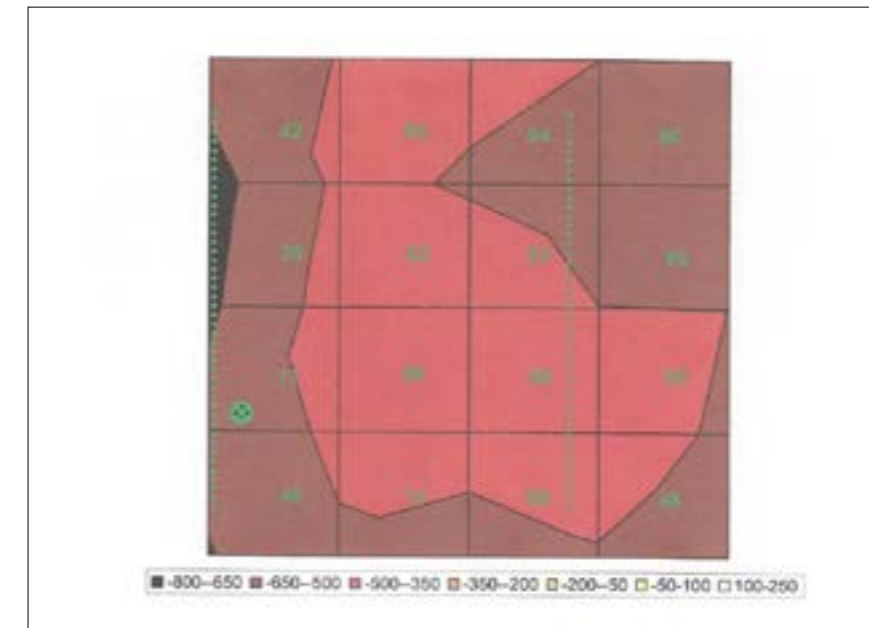
HALF CELL MAP FOR TEST PANEL 14- DECK LEVEL 6

Test Panel 14 showed one of the highest levels of corrosion potential. In the results diagram below, 2 cracks were present shown by the dotted line and in the broken out area, shown by the circle, surface corrosion was observed.

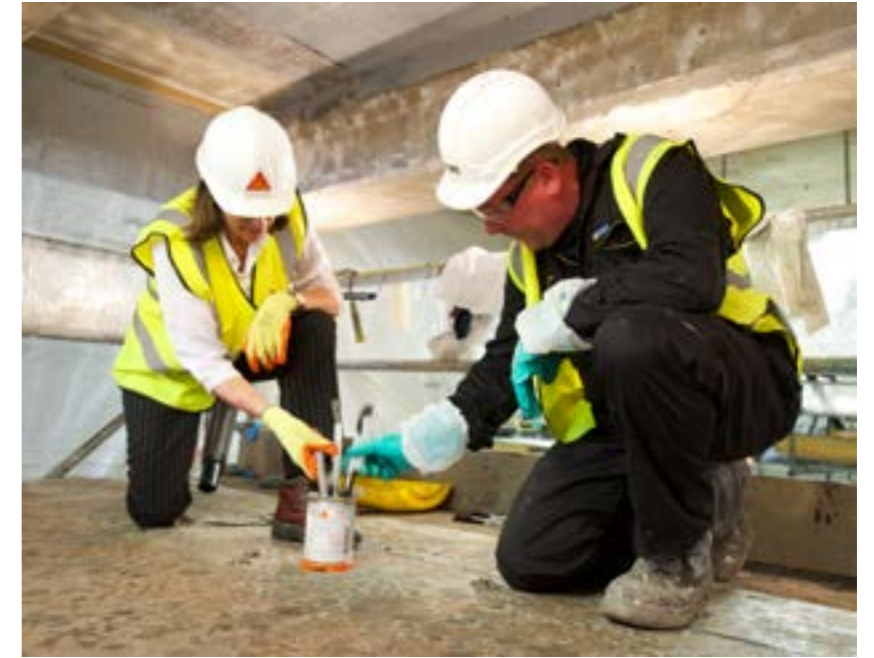
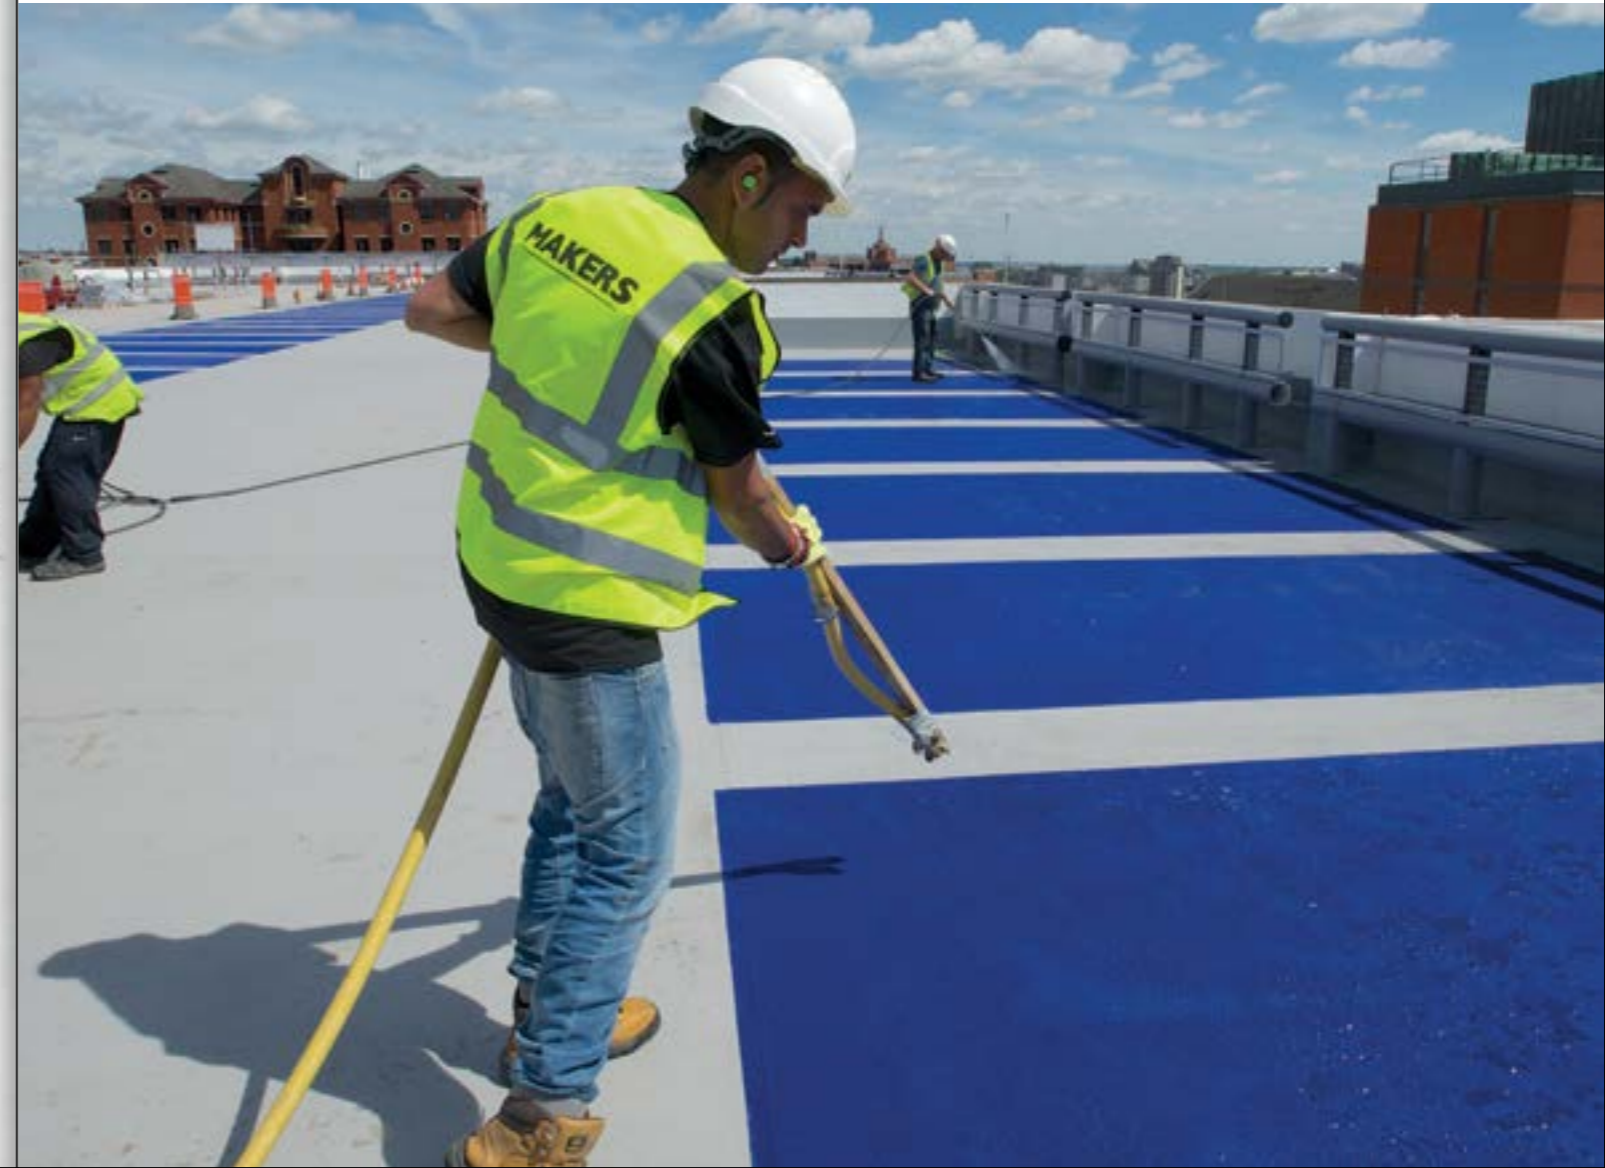
After concrete repairs were completed, the exposed concrete building façade was coated with a flexible anti-carbonation paint which fully conforms to the requirements of BS EN1504 - 2 as a protective coating and had to be:

- Suitable for protection against ingress (Principle 1, method 1.3 of EN 1504-9).
 - Suitable for moisture control (Principle 2, method 2.3 of EN 1504-9).
 - Suitable for increasing the resistivity (Principle 8, method 8.3 of EN 1504-9).
- Whilst a variety of colours are available the anti-carbonation coating on the Merriion Centre was generally white to suit the aesthetic finish of the building.
