SIKA AT WORK

COLLEGE GARDENS, BRIGHTON

FLOORING: Sikagard® and MonoTop®

SIKA CONCRETE REPAIR SYSTEM PROTECTS BRIGHTON HOME FROM SEASIDE CORROSION.

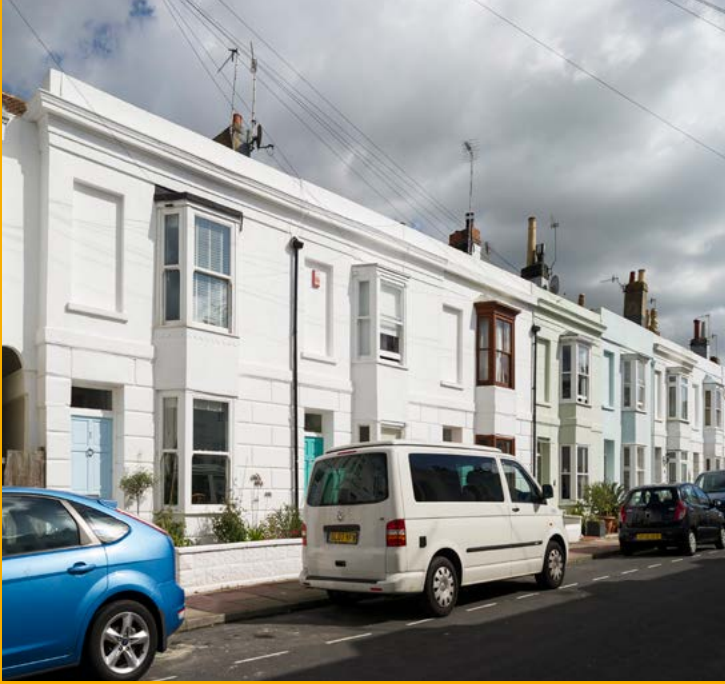
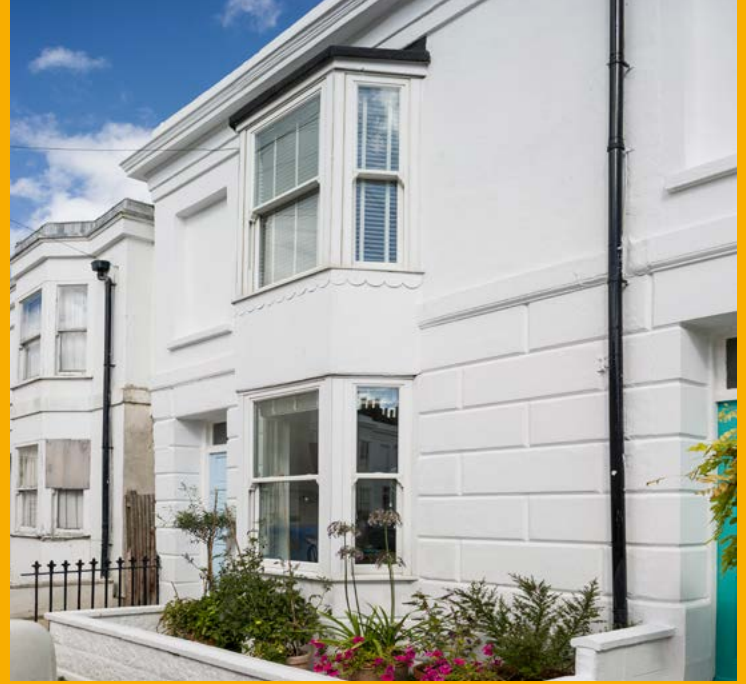
Located just 200 metres from Brighton seafront, the 19th Century terraced home on College Gardens had suffered years of attack due to the marine environment. With the building's rusticated concrete facade showing extreme corrosion, urgent repairs were required. Building refurbishment specialist, RockProtex, was appointed to carry out a comprehensive repair programme – a programme that was to be completed in just three working days.

RockProtex cleaned and protected the concrete's steel reinforcement bars with [Sika® MonoTop®-610](#). After protecting the steel against future corrosion, all damaged concrete across the building façade, supporting beams and an adjoining archway was removed. All areas were then reinstated using [Sika® MonoTop®-615](#) polymer modified concrete repair mortar.

Any minor undulations in the repaired concrete were then restored using an overall levelling coat of [Sika® MonoTop®-620](#), leaving a perfect repair and replacement of the original concrete substrate. Used as a finishing and levelling coat, [Sika® MonoTop®-620](#) helps to restore the surface impaired concrete and provide a continuously, smooth surface prior to the application of the further protective coatings.

The repairs were completed with the application of two coats of [Sikagard®-675W ElastoColor](#). With a proven track record and a simple installation process, the protective/decorative anti-carbonation coating can be applied over existing coatings or directly onto the concrete to offer protection and aesthetic enhancement.
