# SIKA AT WORK

## COLLEGE GARDENS, BRIGHTON

FLOORING: Sikagard® and MonoTop®

## SIKA CONCRETE REPAIR SYSTEM PROTECTS BRIGHTON HOME FROM SEASIDE CORROSION.

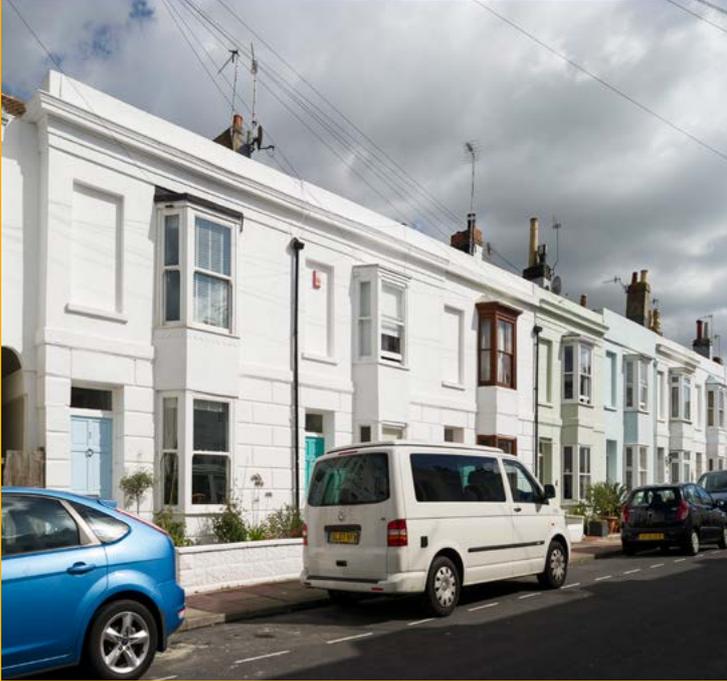
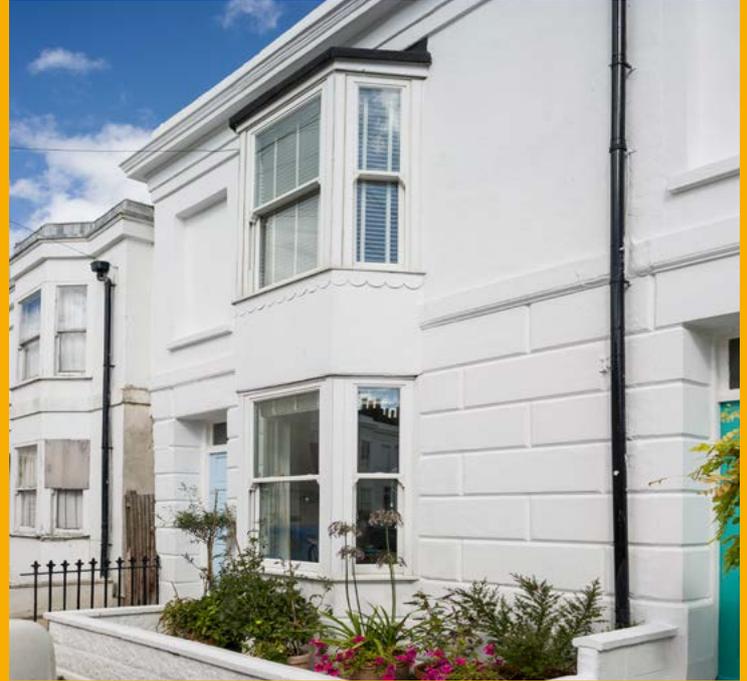
Located just 200 metres from Brighton seafront, the 19th Century terraced home on College Gardens had suffered years of attack due to the marine environment. With the building's rusticated concrete facade showing extreme corrosion, urgent repairs were required. Building refurbishment specialist, RockProtex, was appointed to carry out a comprehensive repair programme – a programme that was to be completed in just three working days.

RockProtex cleaned and protected the concrete's steel reinforcement bars with [Sika® MonoTop®-610](#). After protecting the steel against future corrosion, all damaged concrete across the building façade, supporting beams and an adjoining archway was removed. All areas were then reinstated using [Sika® MonoTop®-615](#) polymer modified concrete repair mortar.

Any minor undulations in the repaired concrete were then restored using an overall levelling coat of [Sika® MonoTop®-620](#), leaving a perfect repair and replacement of the original concrete substrate. Used as a finishing and levelling coat, [Sika® MonoTop®-620](#) helps to restore the surface impaired concrete and provide a continuously, smooth surface prior to the application of the further protective coatings.

The repairs were completed with the application of two coats of [Sikagard®-675W ElastoColor](#). With a proven track record and a simple installation process, the protective/decorative anti-carbonation coating can be applied over existing coatings or directly onto the concrete to offer protection and aesthetic enhancement.
