# SIKA AT WORK

## CHRIST CHURCH URC CHELMSFORD, ESSEX

REFURBISHMENT: Sika® MonoTop®-610/-615 and Sikagard®-550W Elastic

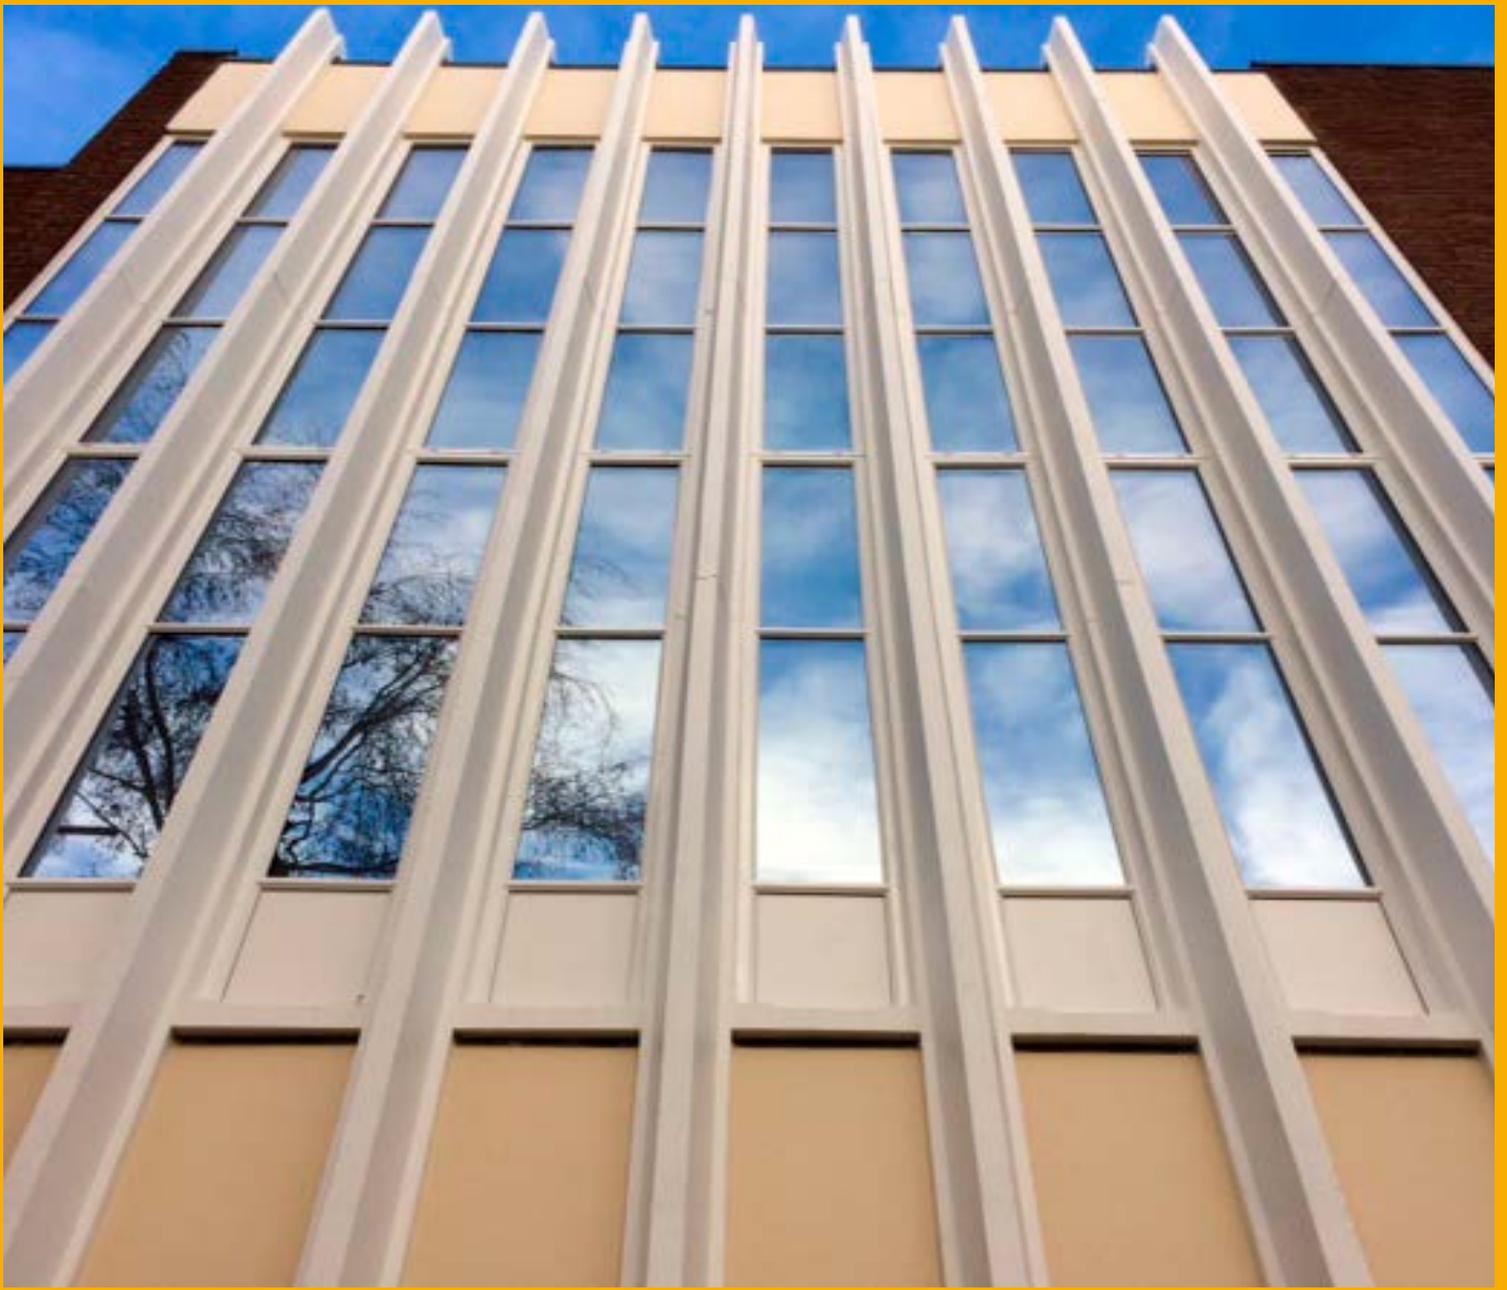
Christ Church URC in Chelmsford, Essex provides a hub for the whole community, hosting mother and toddler groups, social meetings and youth-based events as well as traditional religious services. The church's brick-clad structure includes exposed concrete columns which were showing signs of deterioration due to carbonation together with other factors causing the steel reinforcement to corrode and the surface to crack and spall, leaving the reinforcement bar exposed in areas.

To make good the damage and eliminate the risk of future corrosion in the spalled areas, [Sika® MonoTop®](#), a proven, high-performance concrete repair and protection system, was specified.

With work beginning in November 2016, Bloomfield Construction applied [Sika® MonoTop®-610](#), a high-performance, one-component, cementitious polymer-modified corrosion protection coating to the exposed reinforcement. Brush applied, [Sika® MonoTop®-610](#) simply required mixing with water to provide a superb, anti-corrosive protection to exposed reinforcement and bonding in preparation for concrete repairs using Sika® MonoTop®-615.

This high-build, hand-placed concrete repair mortar – which also requires nothing more than simple water mixture for preparation – is the perfect repair mortar for delaminated, weak, damaged and deteriorated concrete. [Sikagard®-550 W Elastic](#), a one component, plasto-elastic, anti-carbonation coating system, provided the high-quality, elastomeric properties to protect the concrete from the risk of further carbonation and improve the aesthetics. [Sikagard®-550 W](#) is solvent-free, and even at low temperatures, offers superb crack-bridging capabilities in concrete structures.

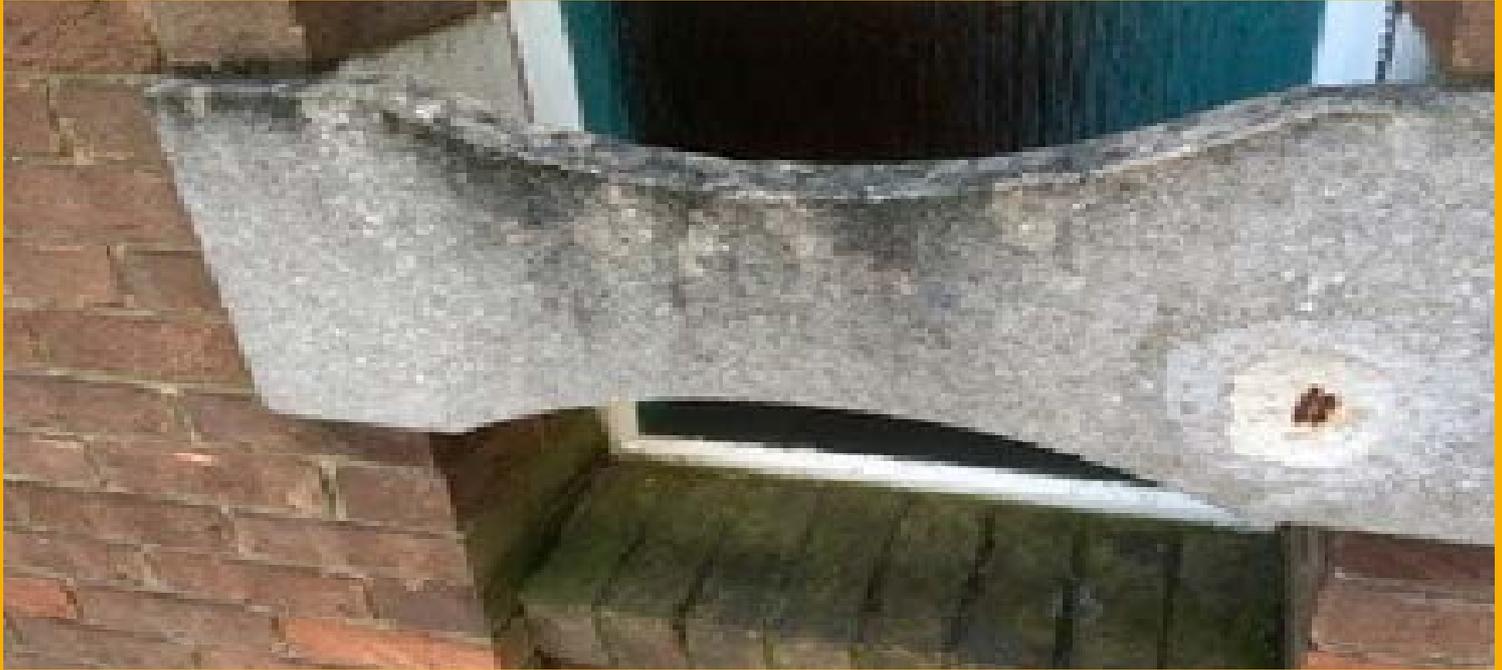
Christ Church URC is now able to display a smart, fully-protected façade, free of cracks and spalls and the immediate threat of carbonation-based corrosion.
