CLIFTON DOWN SHOPPING CENTRE MSCP, BRISTOL

REFURBISHMENT: Sikafloor® RB58 Pronto System

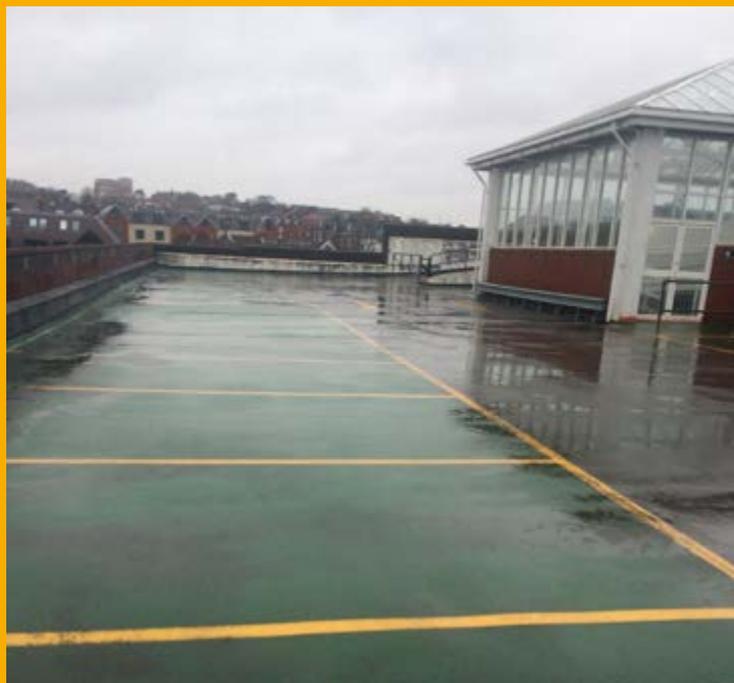
Before

Decks six and seven of the Clifton Down Shopping Centre multi-storey car park in Bristol had been left neglected since the site was built in the 1970s. For many years, planning permission had been sought to bring the car park's upper floors into public operation. With approval denied, the exposed asphalt decks suffered cracks and became detached from the concrete substrate.

Comprising of several layers to guarantee a robust, watertight, and crack bridging system, [Sikafloor® RB58 Pronto system](#) more than fulfilled the contractor's requirements. In preparation for repairs, the failing asphalt was removed from both decks and repairs were carried out to the concrete substrate. The [Sikafloor® RB58 Pronto system](#) was then applied.

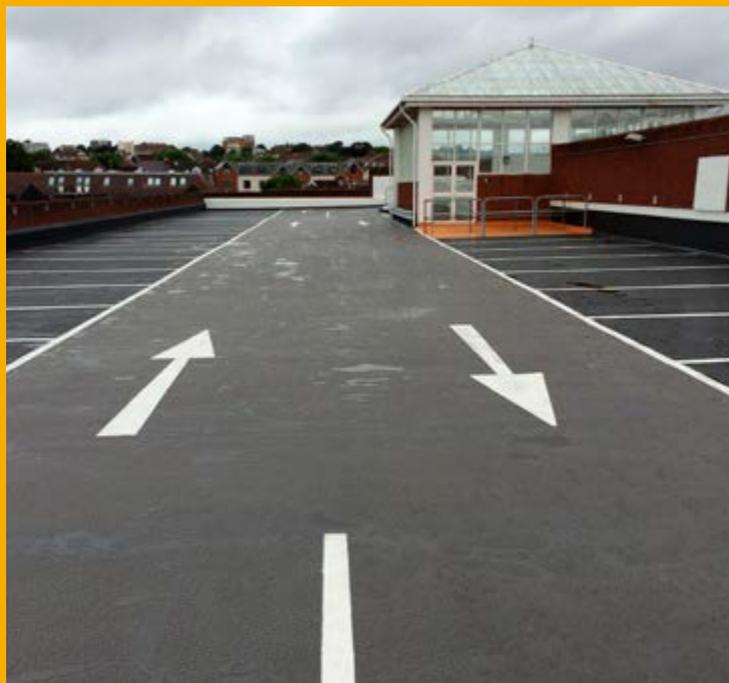
After

Firstly, [Sikafloor®-11 Pronto fast-curing primer](#) was applied to the decks' 1,500m² substrate. To fully-strengthen the base coat, which also included hard wearing [Sikafloor®-32 Pronto](#), Sika® Reemat Premium, was applied. A further layer of [Sikafloor®-32 Pronto](#) was used to encapsulate the Sika® Reemat Premium, and once cured, [Sikafloor®-32 Pronto](#) filled with 1:2 Sikafloor®-Pronto Filler, was installed. This was followed by a proprietary Sika aggregate which added an extra layer for durability and slip resistance.

[Sikafloor®-18 Pronto](#), which has excellent mechanical and chemical resistance, provided the system's fast-curing, solvent-free coloured seal, giving the decks a superb skid and slip-free finish sufficient to meet HSE regulations. [Sikafloor® RB58 Pronto system](#), which also comes with a 10-year warranty, has been tested in accordance with DIN EN 1062-7 for dynamic crack bridging class B 4.2. This test is carried out at a temperature of -20°C, a harsher environment than even the UK winter normally provides.
