# SIKA AT WORK

## HEATHGATE ESTATE, NORWICH

REFURBISHMENT: Sika® MonoTop® and Sika® Margel

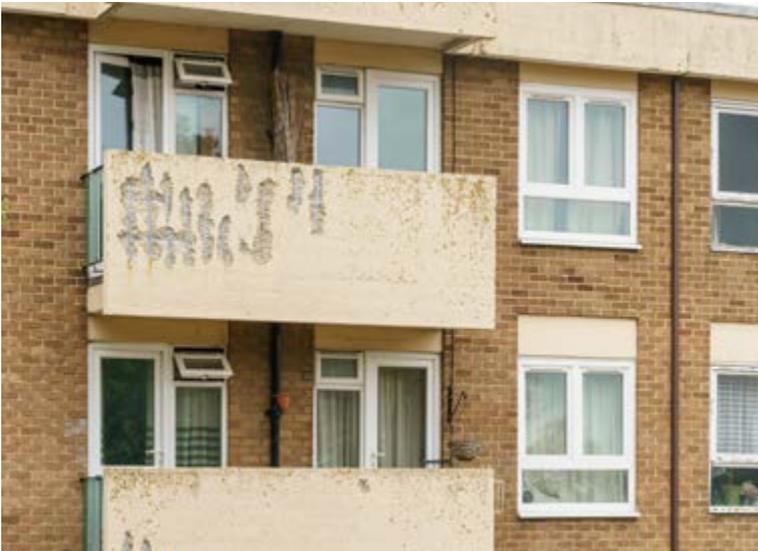
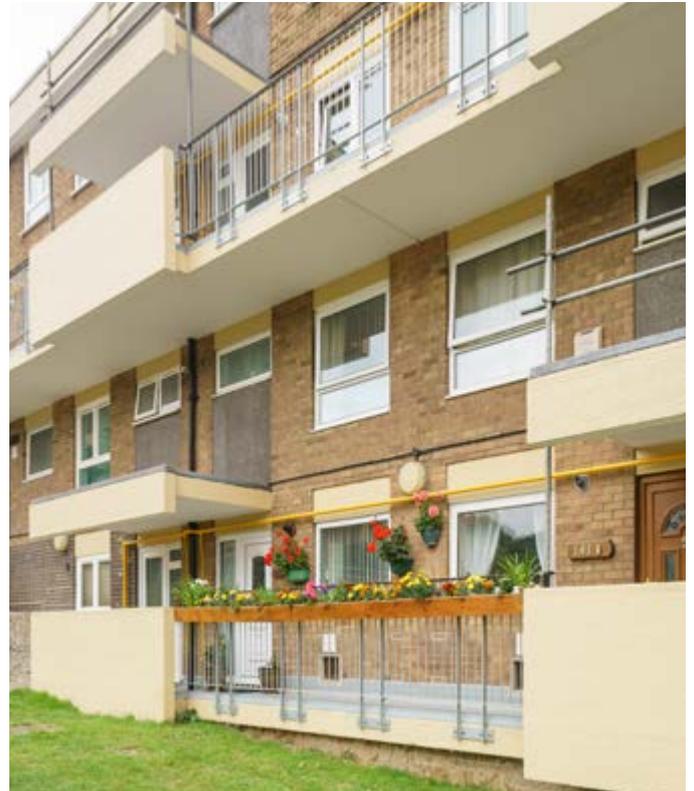
Spalled concrete had occurred throughout the 50-year-old buildings, with steel reinforcement exposed in many areas. With the health and safety of the occupants at risk, the buildings' owners, Norwich City Council, required a proven concrete repair and protection system with long-term.

Specified by main contractors, JB Specialist Refurbishments, the [Sika® MonoTop®](#) repair mortar system is renowned for its simple application, as well as offering superb durability and reinforcement for a range of cementitious and steel applications. A full structural report carried out by engineering firm, Conisbee, outlined the required refurbishment at Heathgate. It revealed large areas of the buildings were in a poor state of disrepair due to corrosion initiated by carbonated concrete.

During initial repairs, which started in February 2016, the buildings' external coatings were removed in the delaminating areas, where the coating was found to be well adhering after adhesion and compatibility tests, these areas remained. Hammer test surveys were also undertaken to ascertain the extent of both visual and non-visual defects and the subsequent repair areas broken out in preparation for reinstatement. The exposed repair area surfaces were applied with Sika® [Monotop®-610](#), a high-performance, one-component, cementitious [polymer-modified primer](#).

[Sika® Monotop®-610](#) simply required mixing with water to provide a superb, reinforcement corrosion protection and bonding primer in preparation for concrete repairs using [Sika® Monotop®-615](#). This [concrete repair mortar](#) – which also requires nothing more than simple water mixture for preparation – is the perfect reinforcement mortar for delaminated, weak, damaged and deteriorated concrete.

To address the carbonation induced corrosion within the concrete which hadn't yet propagated cracking or delamination, [Sika® Margel VPI 580](#), a patented vapour-phase corrosion inhibitor and part of Sika's Total Corrosion Management portfolio, was also installed to all concrete elements.

[Sikagard®-550 W Elastic](#), a one component plasto-elastic anti-carbonation coating system provided the final application over the existing sound well adhering coating. [Sikagard®-550 W Elastic](#) is solvent-free, and even at low temperatures, offers superb crack-bridging properties in concrete structures.
