# SIKA AT WORK

## PAGE HOUSE CAR PARK EPSOM, SURREY

REFURBISHMENT: Sikafloor® RB28 Pronto System

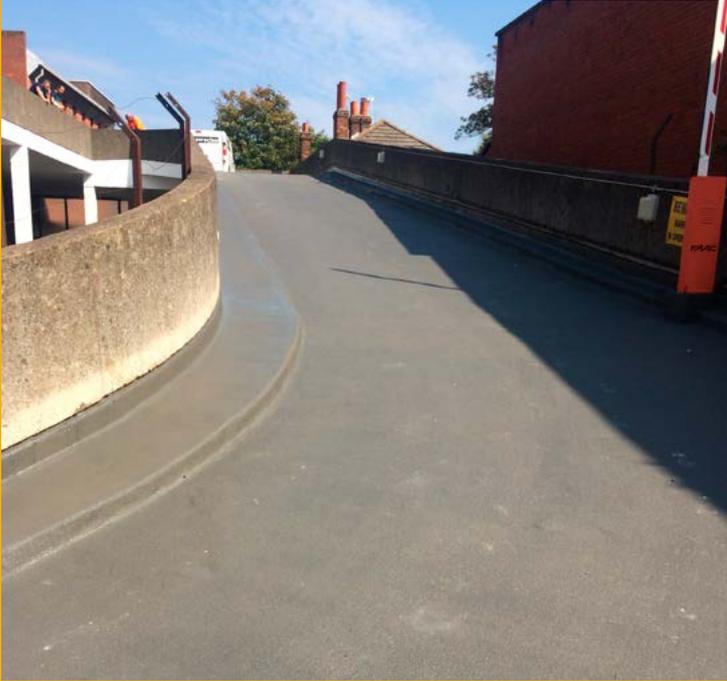
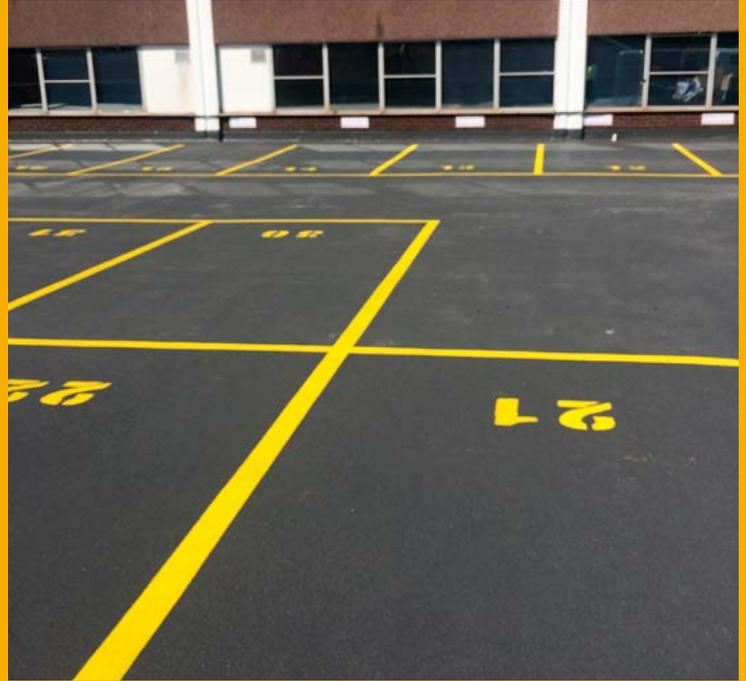
A total of 500m<sup>2</sup> Sikafloor®-RB28 was applied to the car park's existing asphalt surface. The first layer, Sikafloor®-10 Pronto, provided the surface's four-part, low-viscosity, fast-curing primer. This was followed by Sikafloor®-32 Pronto, renowned for its superb crack-bridging properties, which, was filled with 1:2 Sikafloor®-Pronto Filler and quartz sand.

Sikafloor®-18 Pronto, which offers excellent mechanical and chemical resistance, provided the system's fast-curing, solvent-free seal coat, giving the deck a superb skid and slip-free finish sufficient to meet HSE regulations. For the ramps, a double layer of Sikafloor®-32 Pronto, and Sikafloor®-18 Pronto was applied, as well as a priming layer of Sikafloor®-10 Pronto.
