JODRELL BANK OBSERVATORY, CHESHIRE

REFURBISHMENT: Sika® Ferrogard® and Sikagard®

SIKA MAKES LIGHT WORK OF JODRELL BANK OBSERVATORY REPAIRS.

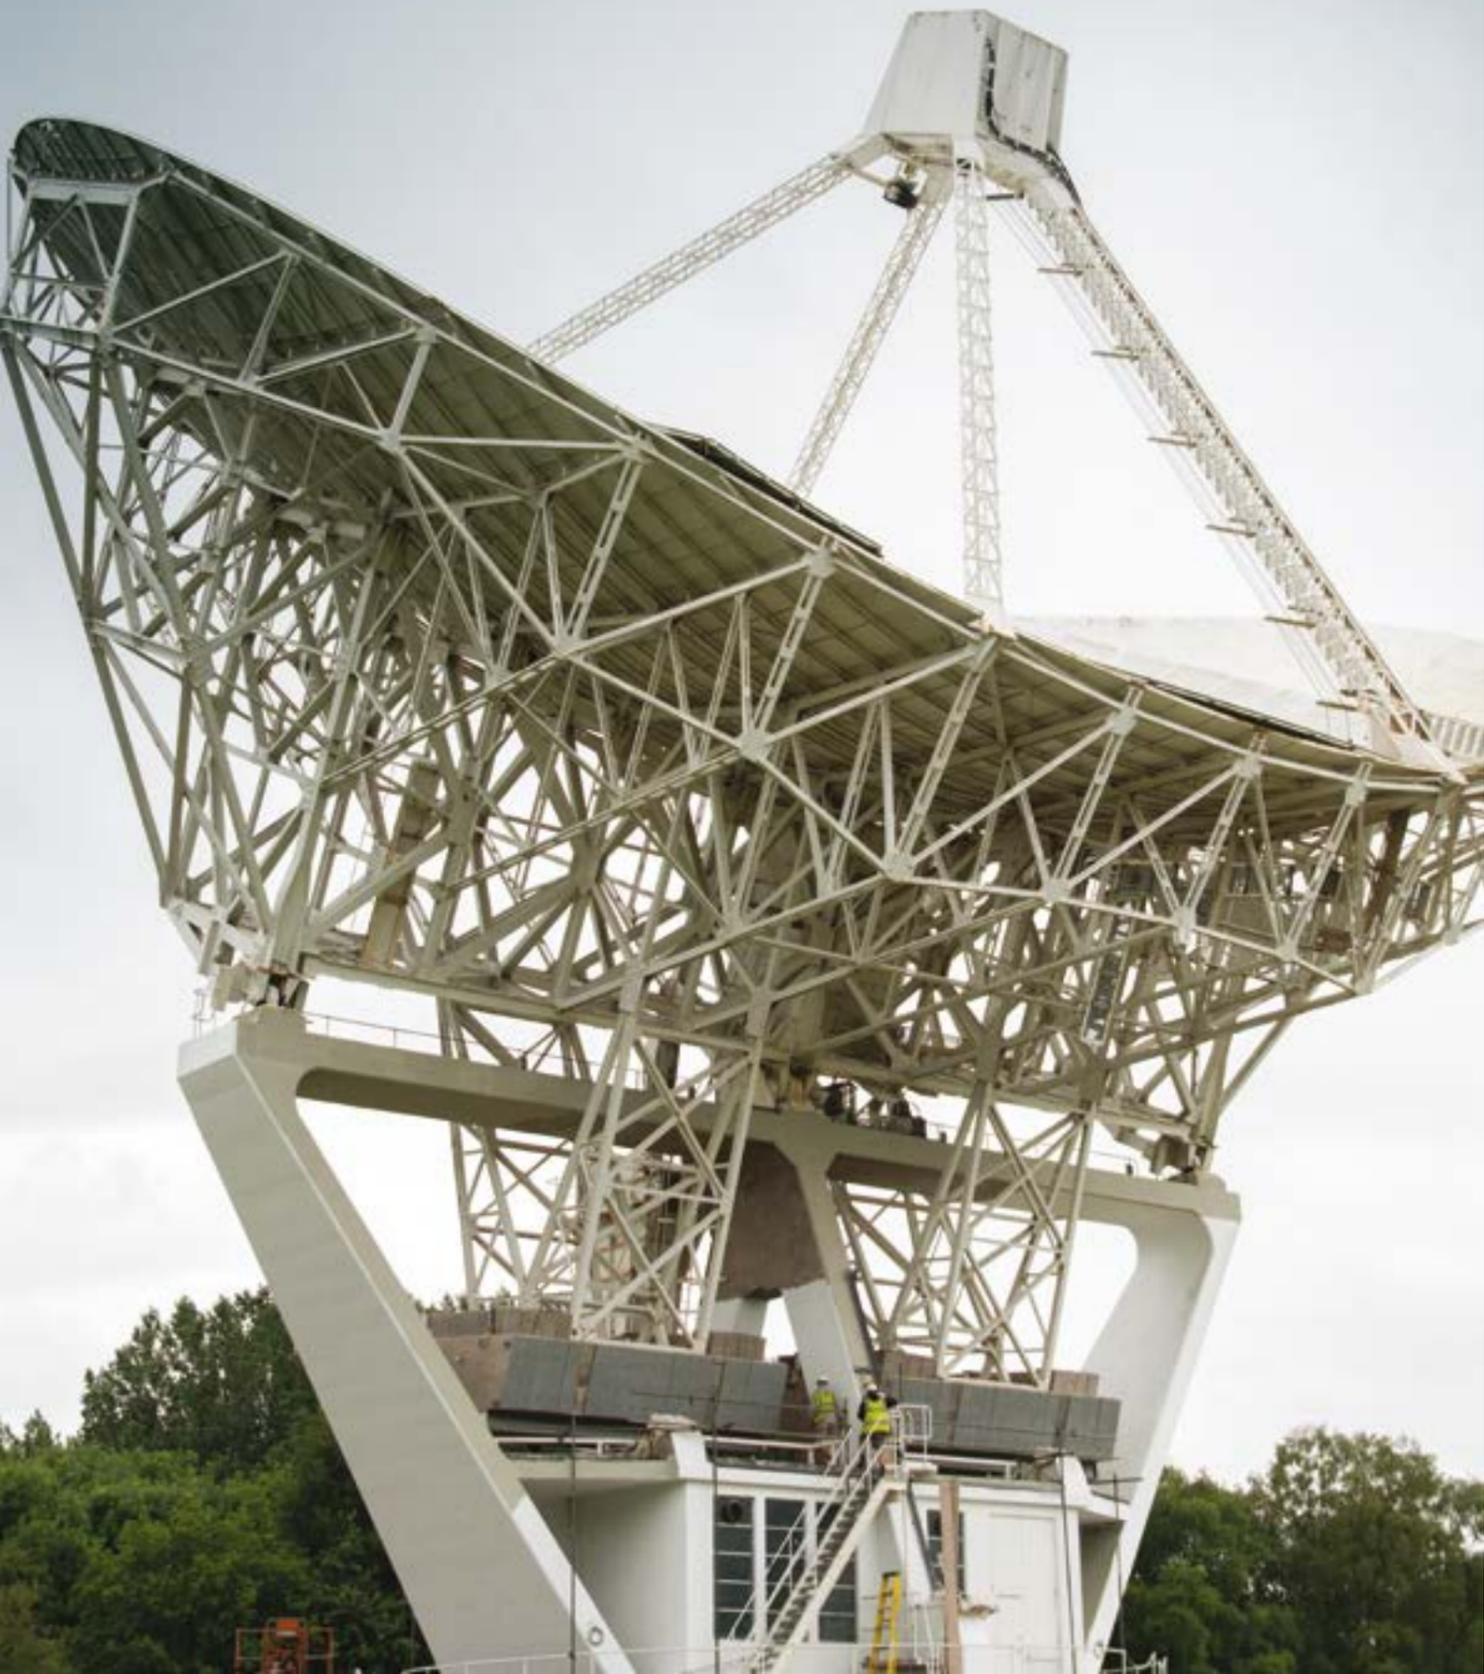
At Jodrell Bank Observatory in Cheshire – the world renowned centre for radio astronomy – Sika has demonstrated its ability to deliver high performance concrete repair and protection solutions with a comprehensive range of the company's products helping to repair a concrete frame supporting their Mark II telescope .

When cracking and spalling was discovered in the telescope's concrete base, the University of Manchester required a specification to restore the concrete profile and provide future protection. Appointed to complete the refurbishment, contractor Grade 2 utilised a range of high performance systems from Sika as part of a complete package solution.

Supporting the 25x38 metre diameter telescope dish, the concrete frame stands 25 metres high and was constructed fifty years ago. To make primary repairs, Grade 2 utilised cherry pickers to apply the two-component Sika® MonoTop® system – comprising a bonding primer and reinforcement coating followed by a concrete repair and reprofiling mortar.

Once the repairs were made, Sika® Ferrogard®-903 was spray-applied to the external elements. Easy to apply and cost-effective, Sika® Ferrogard®-903 inhibits corrosion by delaying its start and dramatically slowing its rate, extending the maintenance and service life cycle of reinforced concrete. The surface applied system penetrates the concrete to provide a protective layer around steel reinforcement whilst maintaining the aesthetic of the structure.
