Sika at Work

Roofing

Case Study at Coombe Hill Golf Club, Kingston Upon Thames

Application Field: **Decothane Gamma 20**

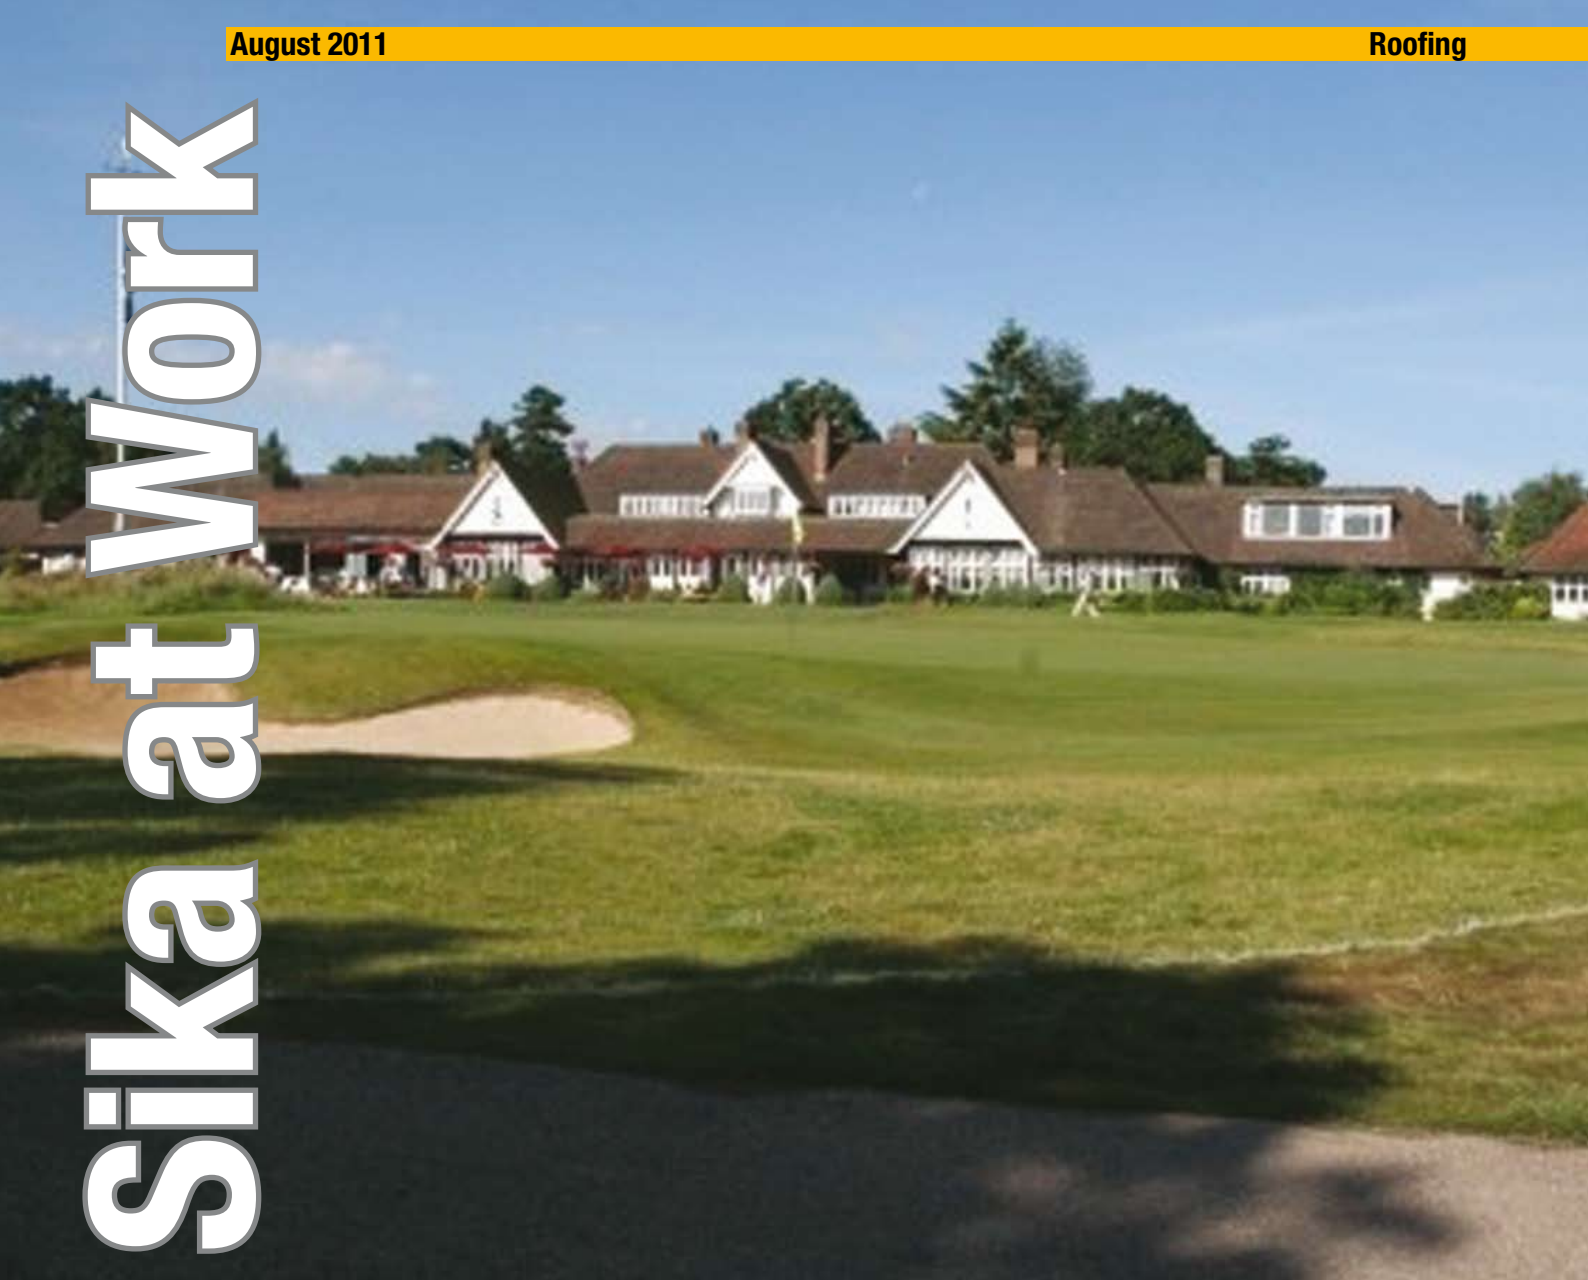
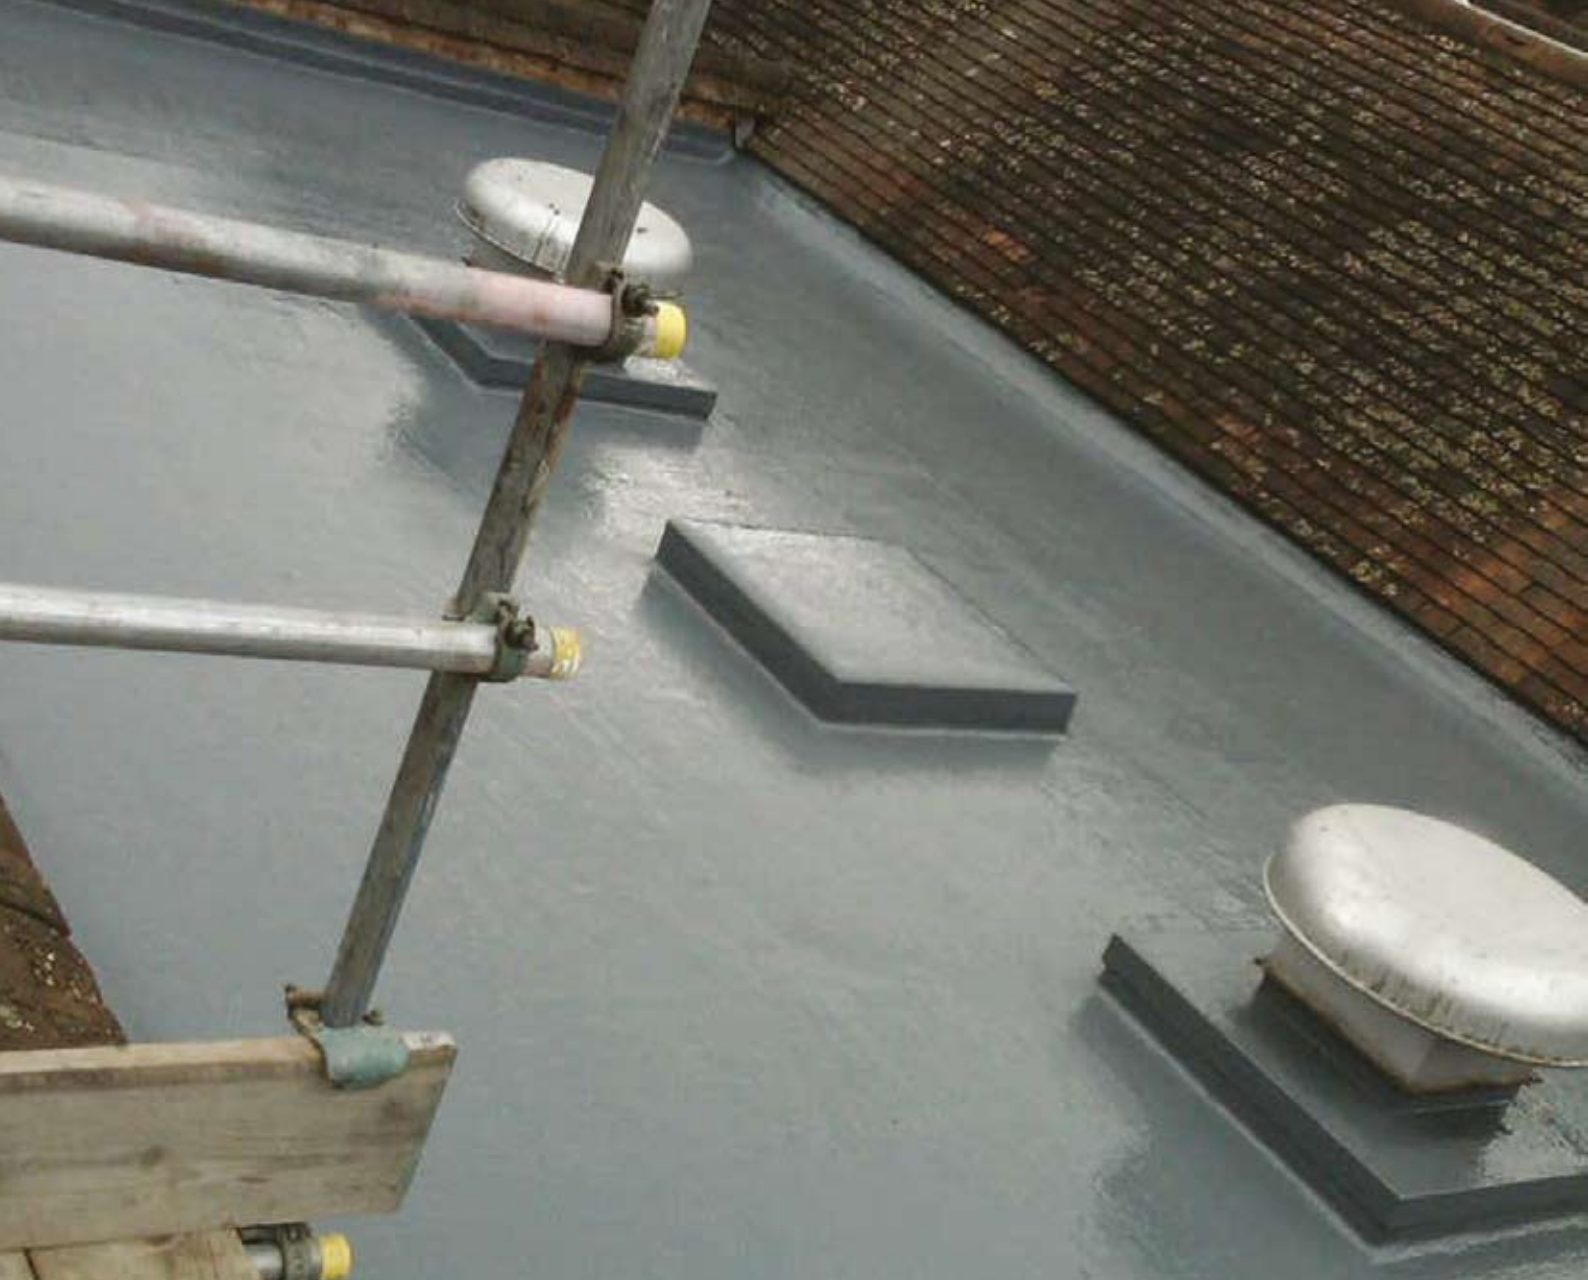
The existing solar painted asphalt on the roof of the club house had failed. This was allowing water ingress which was causing internal damage.

Sika Liquid Plastics' superior waterproof roof membrane -Decothane Gamma 20 - was specified for the re-waterproofing. Decothane is a cold applied product that cures to provide completely seamless protection. The full system consists of a Decothane Base Coat, fully reinforced with Reemat Premium Glass Fibre Matting, and completed with a Decothane Top Coat in Slate Grey.

Decothane was chosen for its ease of application, and because it is also completely seamless and has a proven track record of successful applications. The full system is completely cold applied, thus eliminating the need for any heat or naked flame on the roof, and once installed it is guaranteed to last for at least 20 years.
