SIKA AT WORK

SERVICE RESERVOIR ACCESS COVERS, EAST SUSSEX, UNITED KINGDOM

WATERPROOFING: Sikalastic®, SikaTop®, Sikagard®

PROTECTION OF SERVICE RESERVOIR ACCESS COVERS

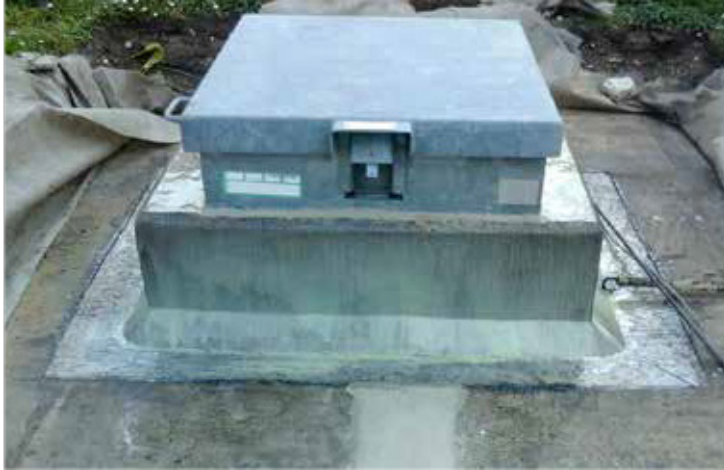
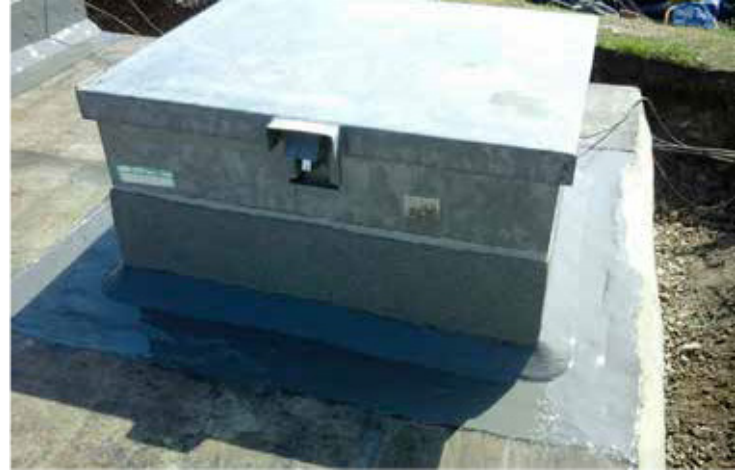
The concrete surface was ground to remove all contaminants. A fillet of SikaTop® 586 Seal levelling mortar was then applied at the base of the upstands.

Sikagard® P 770 primer was applied by roller to a damp but surface-dry concrete surface. After 24 hours, two coats of Sikalastic® M 686 were applied by roller. Sikalastic® M 686 achieved the required resistance to rain showers within 3 hours of application.

Grit was applied onto the wet Sikalastic® M 686 on the upstands to provide additional protection prior to backfilling and landscaping.
