SIKA AT WORK

ROOF REFURBISHMENT AT ELDER HOUSE **PROVIDES A STRIKING AND MODERN WATERPROOFING SOLUTION**

ROOFING: Sika® Decothane® Ultra liquid-applied waterproofing system

ELDER HOUSE, MILTON KEYNES

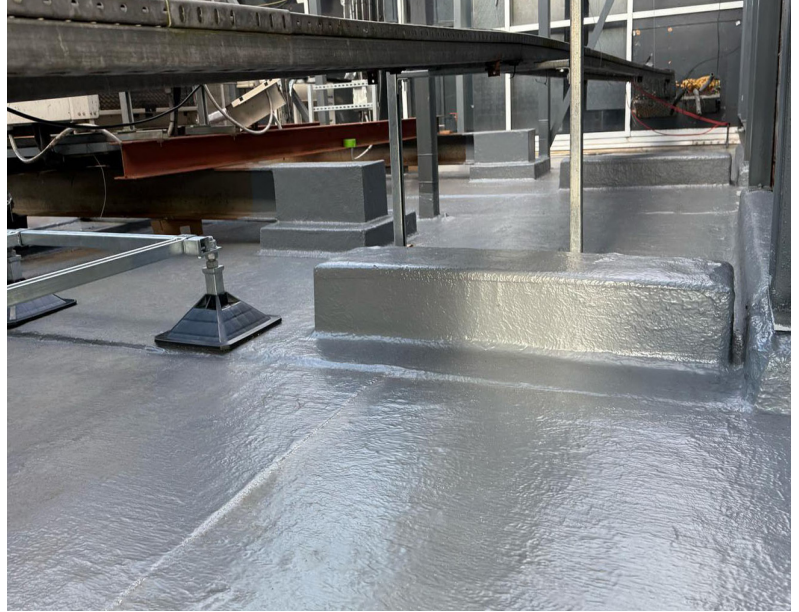
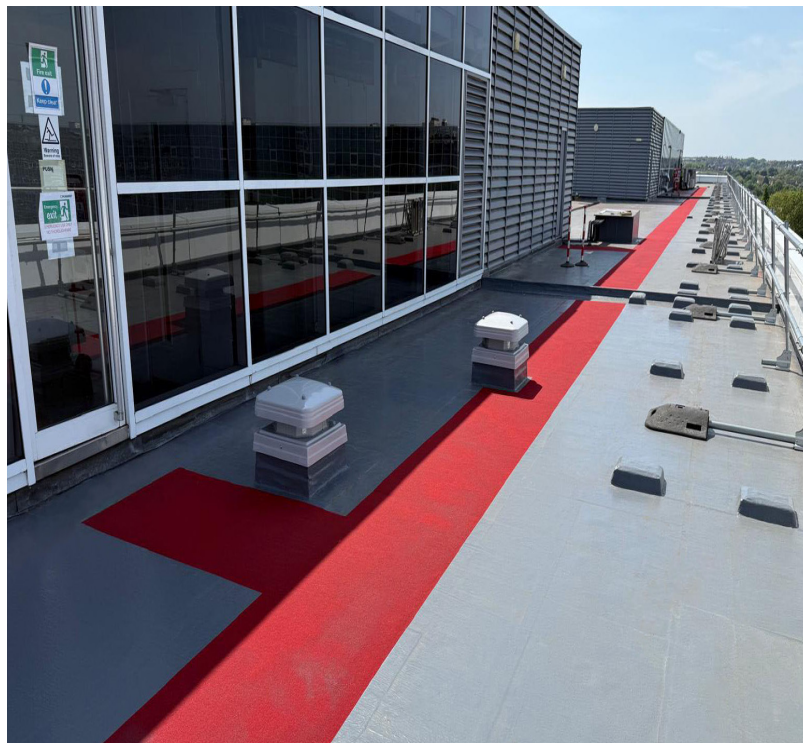
The refurbishment of Elder House's roofs has dramatically improved the visual appeal of the building. The completed Sika Decothane® Ultra system, which was specified in slate grey, provides a sleek, uniform and modern finish, enhancing both the appearance and functionality of the roof. The bright red anti-skid inhibiting walkway stands out as a visually striking feature, guiding maintenance personnel safely across the roof while adding a bold design element.

The roof was then reinstated with Sika® Decothane® Ultra roofing system, which involved repair and priming of the substrate, installation of an air and vapour control layer (AVCL), insulation, and

a carrier membrane before applying the reinforced Decothane® Ultra roof waterproofing system. Maintenance walkways were subsequently installed with an anti-skid inhibiting finish, ensuring safe access for personnel.

Attention to detail was vital, as the roof contained 234 plinths for a redundant Building Maintenance Unit (BMU) track, all of which required precise waterproofing and integration. Existing handrails were removed and reinstated, and upper roof cappings were carefully jet-washed and cleared of moss before refurbishment. Additional complexities included removing large roof access hatches, renewing timber joists and plywood reinstatement to maintain structural integrity and safe building access.
