JODRELL BANK OBSERVATORY, CHESHIRE

REFURBISHMENT: Sika® Ferrogard® and Sikagard®

SIKA MAKES LIGHT WORK OF JODRELL BANK OBSERVATORY REPAIRS.

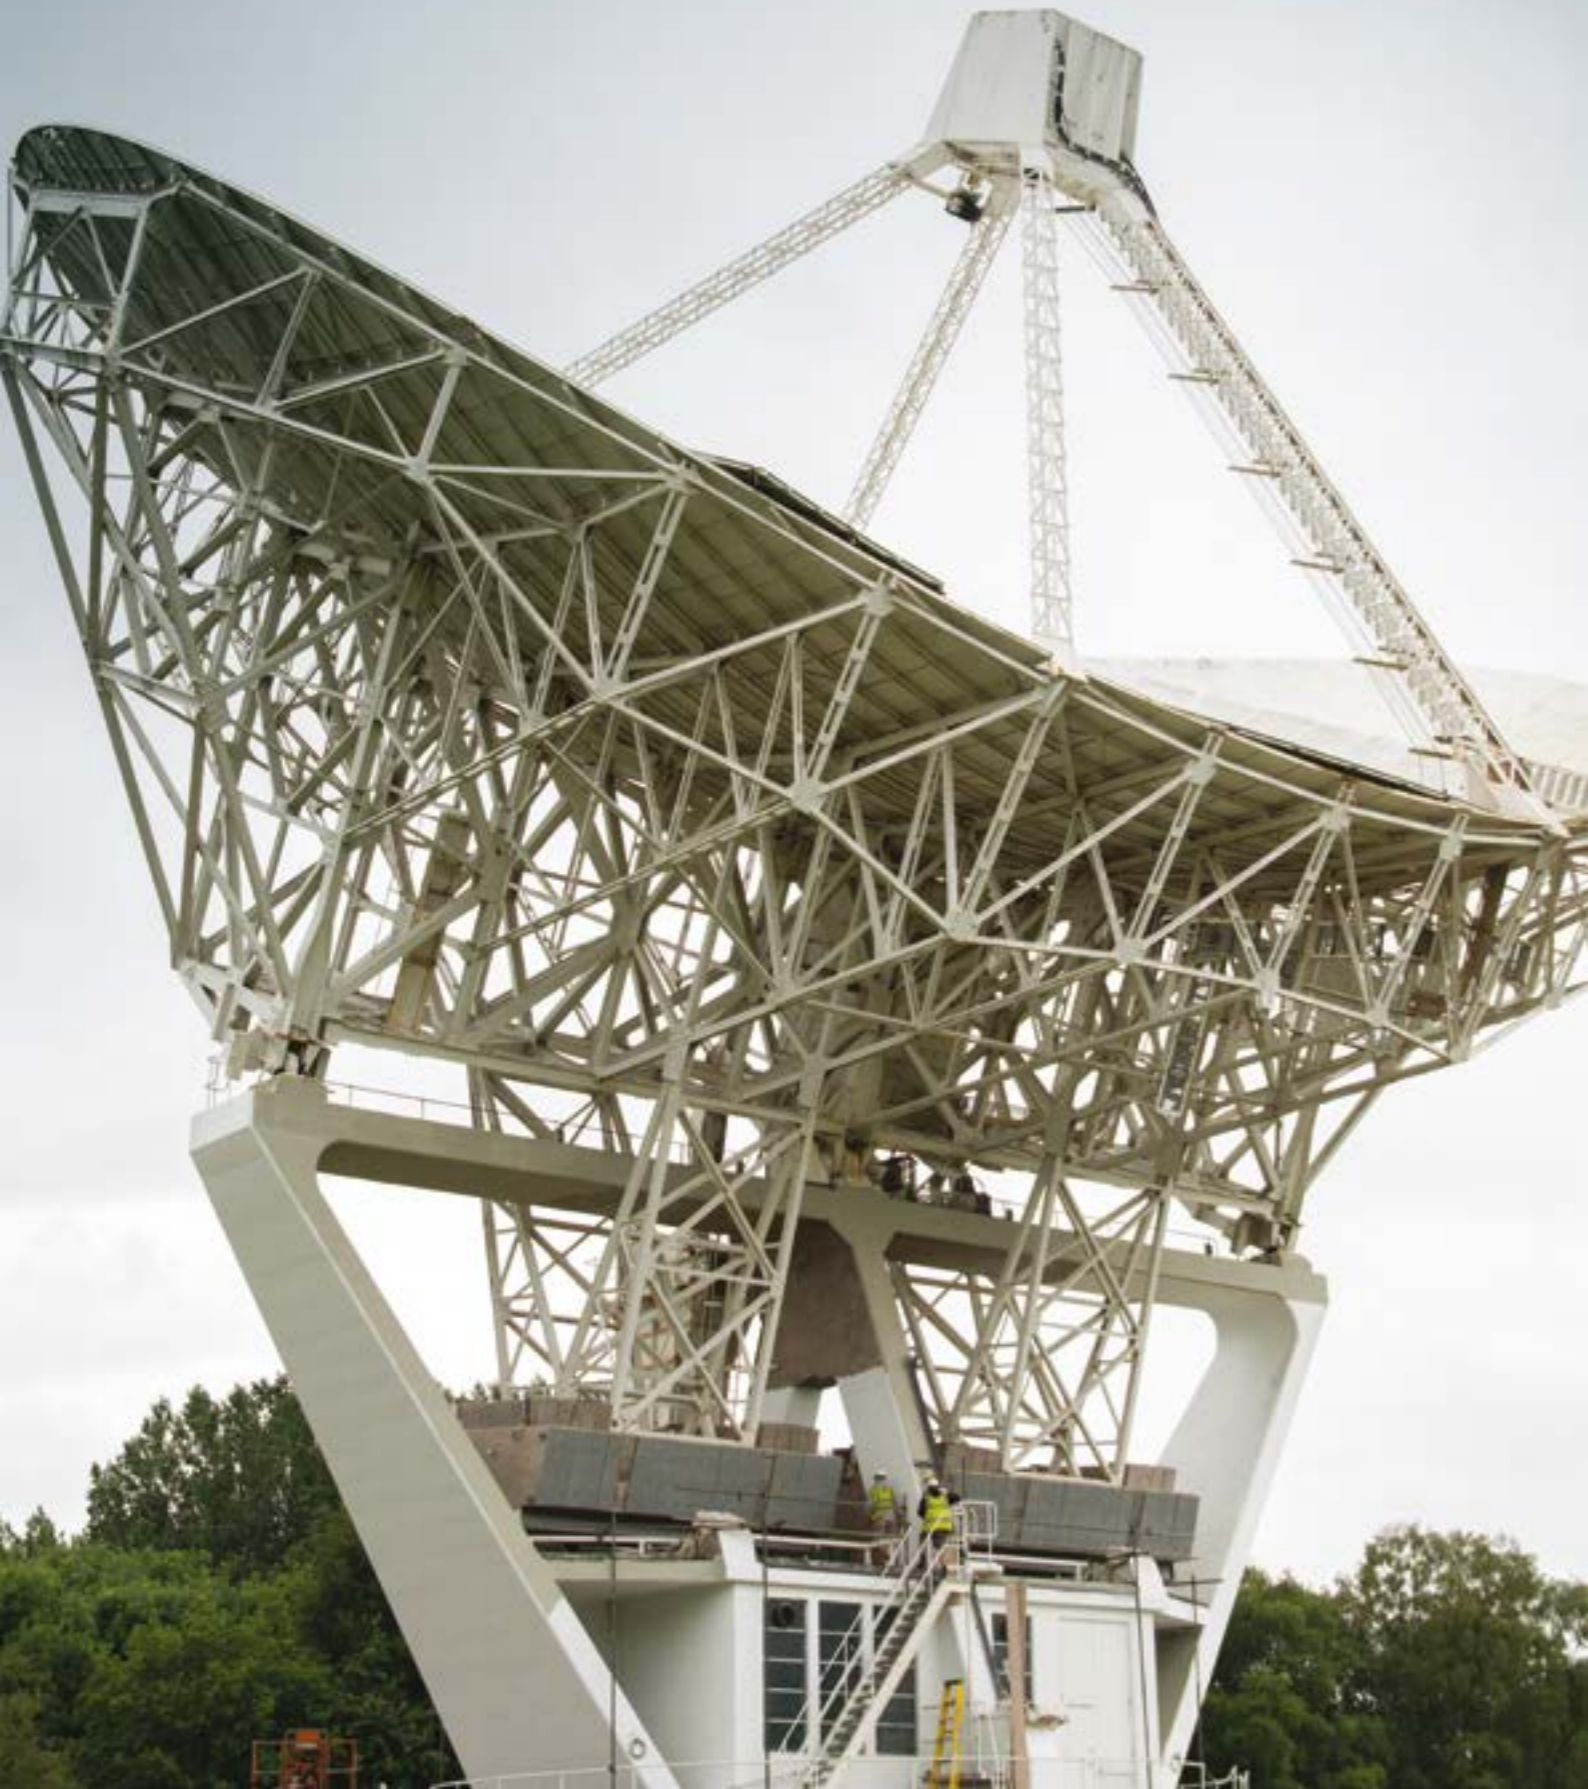
At Jodrell Bank Observatory in Cheshire – the world renowned centre for radio astronomy – Sika has demonstrated its ability to deliver high performance concrete repair and protection solutions with a comprehensive range of the company's products helping to repair a concrete frame supporting their Mark II telescope .

When cracking and spalling was discovered in the telescope's concrete base, the University of Manchester required a specification to restore the concrete profile and provide future protection. Appointed to complete the refurbishment, contractor Grade 2 utilised a range of high performance systems from Sika as part of a complete package solution.

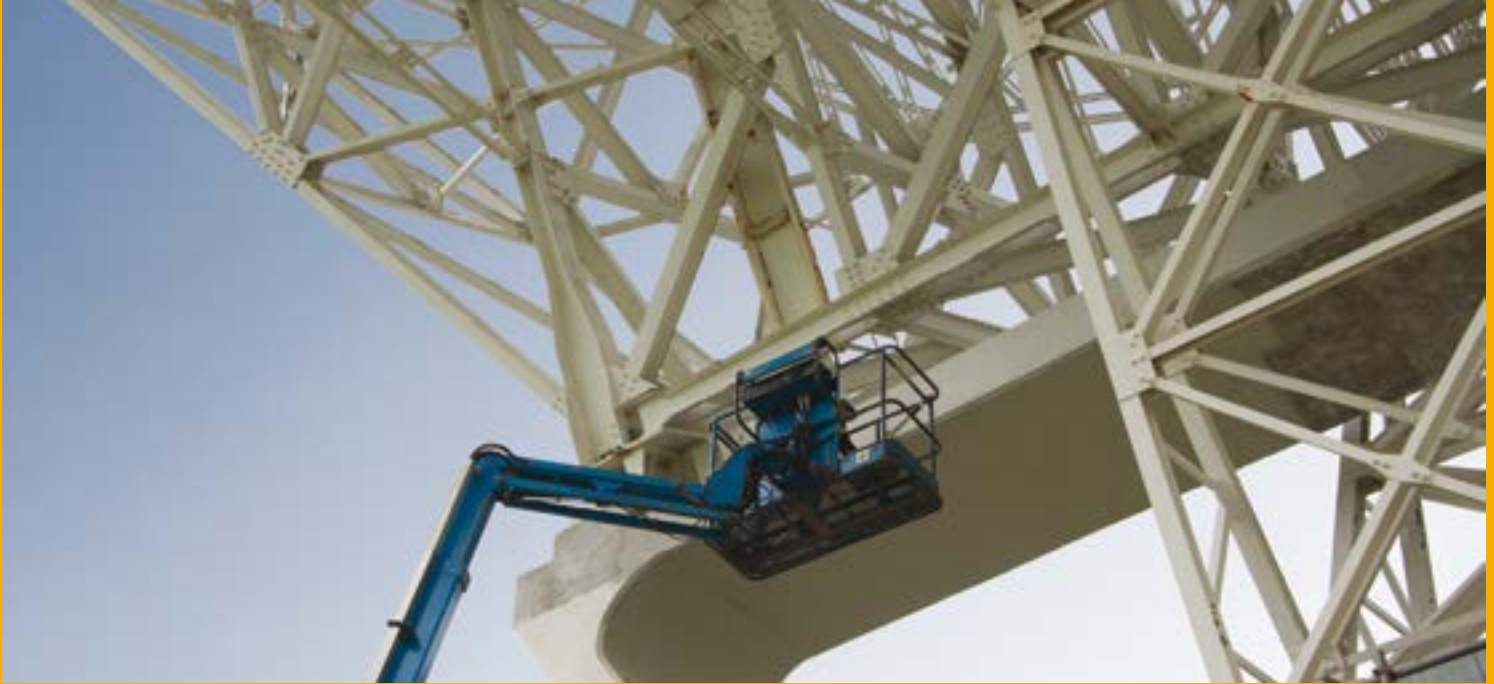
Supporting the 25x38 metre diameter telescope dish, the concrete frame stands 25 metres high and was constructed fifty years ago. To make primary repairs, Grade 2 utilised cherry pickers to apply the two-component Sika® MonoTop® system – comprising a bonding primer and reinforcement coating followed by a concrete repair and reprofiling mortar.

Once the repairs were made, Sika® Ferrogard®-903 was spray-applied to the external elements. Easy to apply and cost-effective, Sika® Ferrogard®-903 inhibits corrosion by delaying its start and dramatically slowing its rate, extending the maintenance and service life cycle of reinforced concrete. The surface applied system penetrates the concrete to provide a protective layer around steel reinforcement whilst maintaining the aesthetic of the structure.

The repairs were followed by the comprehensive application of two coats of Sikagard®-675W ElastoColor. With a proven track record and a simple installation process, the protective/decorative anti-carbonation coating can be applied over existing coatings or directly onto the concrete to offer protection and aesthetic enhancement.
