SIKA AT WORK

BEVERLEY GRAMMAR SCHOOL, YORKSHIRE

REFURBISHMENT: Sika® Ferrogard-903+ and Sika® MonoTop®

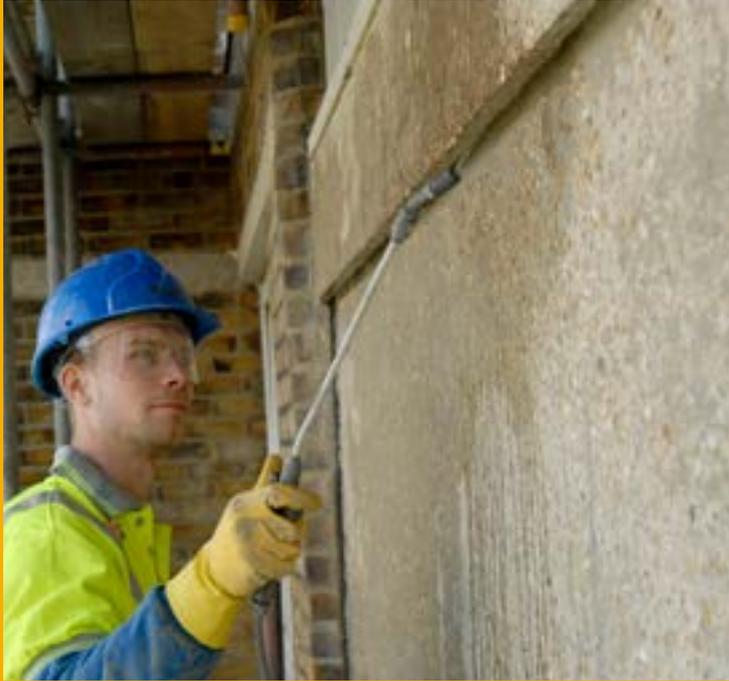
Example of Sika® Ferrogard® being installed

[Sika® Ferrogard®-903](#) was then spray-applied to the refurbished external elements. Easy to apply and cost-effective, [Sika® Ferrogard®-903](#) inhibits corrosion by delaying its start and dramatically slowing its rate, extending the maintenance and service life cycle of reinforced concrete. The surface applied system penetrates the concrete to provide a protective layer around steel reinforcement whilst maintaining the aesthetic of the structure.

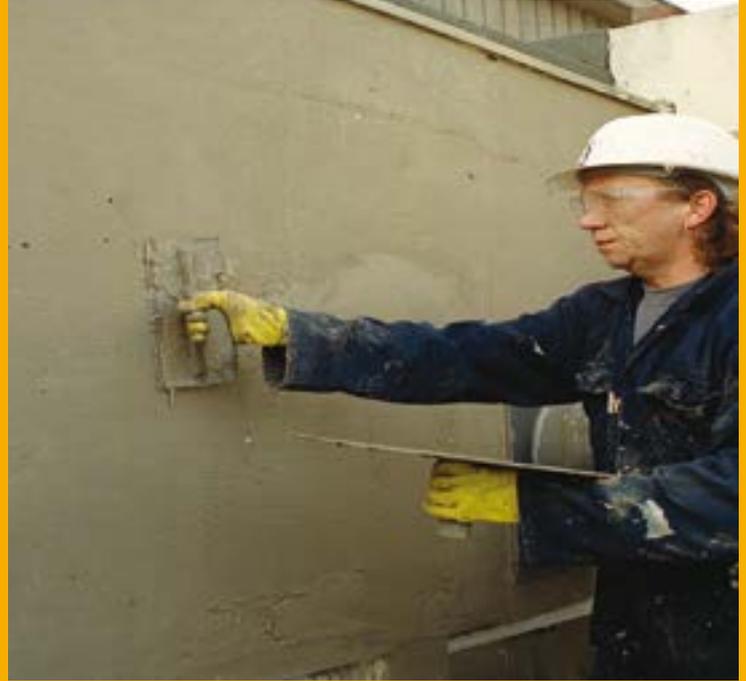
Example of Sika® MonoTop® being installed

Mansell Concrete Repairs applied [Sika® MonoTop®](#) – a cementitious two-component system which consists of polymer modified mortars – to make primary repairs to the damaged concrete and lintels around the windows. Containing silica fume, a highly reactive pozzolan, it is applied “wet-on-wet” to ensure no degradation of the concrete or the structural steel beneath. With a good resistance to water and chloride penetration, it will help to protect the building's concrete exterior from future damage.
