# SIKA AT WORK

## ISLAND GARDENS, LONDON

REFURBISHMENT: Sika® MonoTop® and Sikagard®

### SIKA ENSURES HOUSING ESTATE IS FIT FOR THE FUTURE.

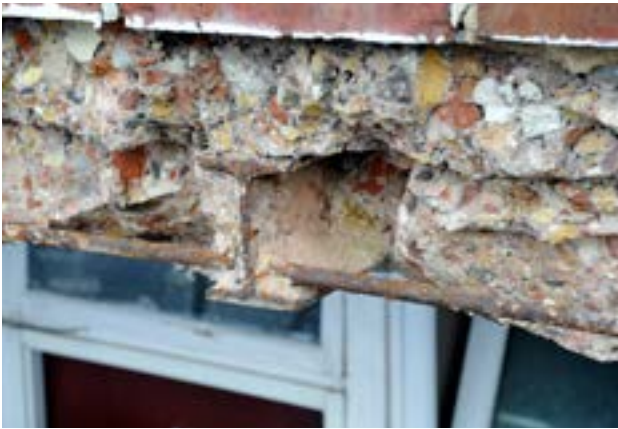
Prepare surface prior to repair ↑

Renocon Ltd applied [Sika® MonoTop®](#) – a cementitious two-component system which consists of polymer modified mortars – to make primary repairs to the damaged concrete frame. With a good resistance to water and chloride penetration, it will help to protect the building's concrete exterior from future damage.

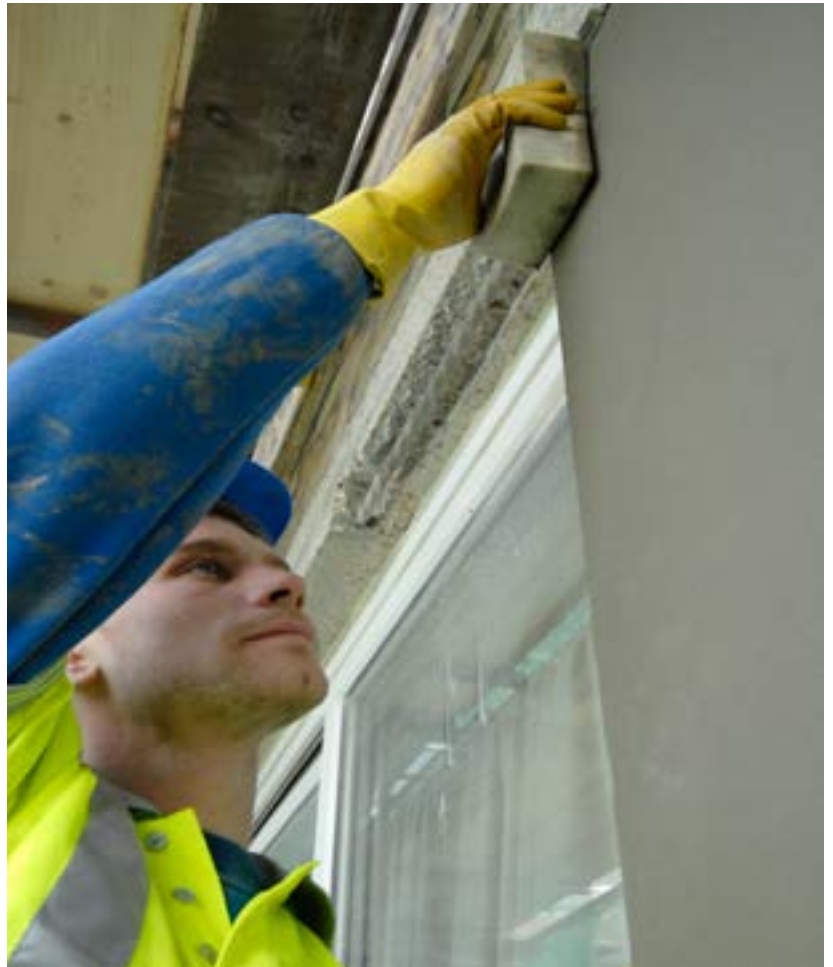
Building looking as good as new →

To provide an overall layer of protection and in order to match the existing surfaces, [Sikagard®-675W ElastoColor](#) was applied to the precast concrete panels. Used to aesthetically enhance concrete substrates and particularly suited as a final protective coating for façades, the anti-carbonation treatment provides a high quality yet economical water-based, acrylic coating to protect against weathering and ageing.
